Flood Analysis – The Gully
Town of Torbay, NL
Final Report
August 16, 2018

Town of Torbay
1288 Torbay Road, P.O. Box 1160,
Torbay, NL A1K 1K4

PROJECT TITLE:
TORBAY FLOOD ANALYSIS GULLY

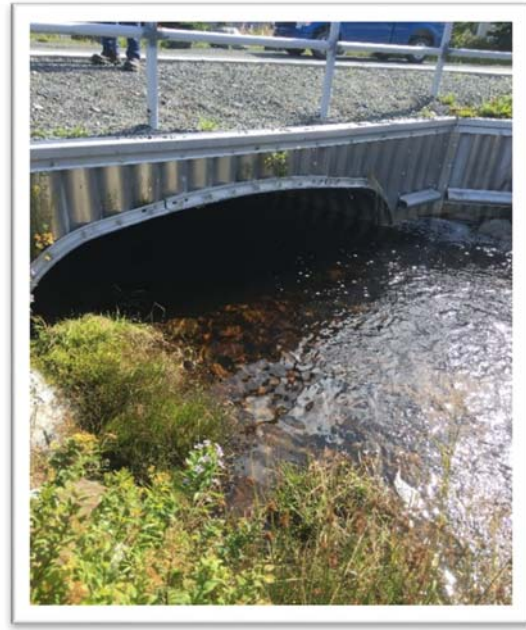
The intent of this report is to analyze the existing stream system as well as “The Gully” area and evaluate the effectiveness of the existing storm drainage system, particularly the 1240mm x 4000mm arch bottomless culvert that is located at the discharge location for “The Gully” on Lynch’s Lane. Given that the elevation of asphalt on Lynch’s Lane as well as the houses on Mahon’s Lane and Lynch’s Lane are relatively close to “The Gully” area, it is important to analyze the floodplain created by a major storm event to see if any of these houses could be affected by a potentially hazardous storm scenario. By analyzing the floodplain generated by the 1D/2D model and the capacity of existing upstream storm sewer infrastructure, the Town of

Figure 1: Arch Bottomless Culvert - Lynch's Lane

It is evident from the modelled 100 year storm events that the arch culvert located on Lynch's Lane is undersized and unable to handle the amount of flow entering "The Gully". Upsizing this culvert is clearly required given the large volume of flow occurring during a 100 year storm event and the small cross-sectional area of the existing culvert. Due to the limited height between the existing culvert and asphalt on Lynch's Lane, the arch bottomless culvert should be upsized to a 6.198m x 1.372m span arch bottomless culvert. The culvert should be replaced with another aluminum culvert because of expected low pH levels of the incoming water from the wetland.

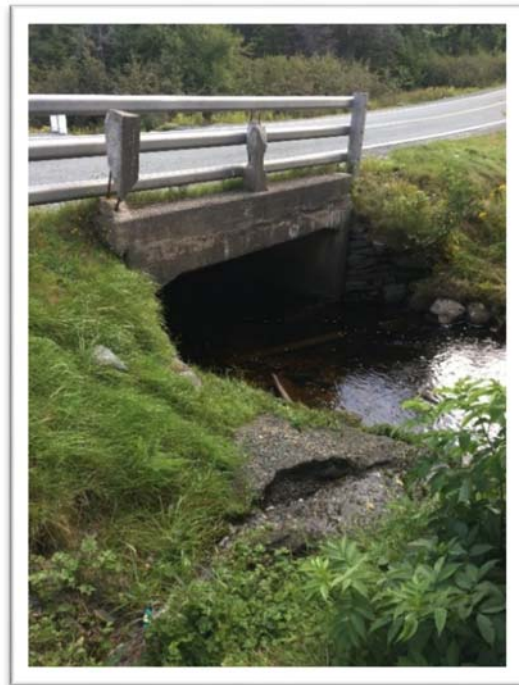
The rectangular concrete culvert located on marine drive was also surveyed. This concrete culvert can be seen in figure 2. It is important to note, from a structural perspective, the deteriorated concrete and exposed rebar on the bridge structure.

Figure 2: Concrete Culvert - Marine Drive

Marine Drive – 1600 *	Poor – Deteriorating	N/A
3500mm Concrete Channel	Concrete & Exposed Rebar

The concrete culvert on Marine Drive has exposed rebar and deteriorating concrete. Progressive Engineering & Consulting Inc. strongly recommends that the bridge be inspected by a structural engineer to ensure that the bridge is structurally sound.

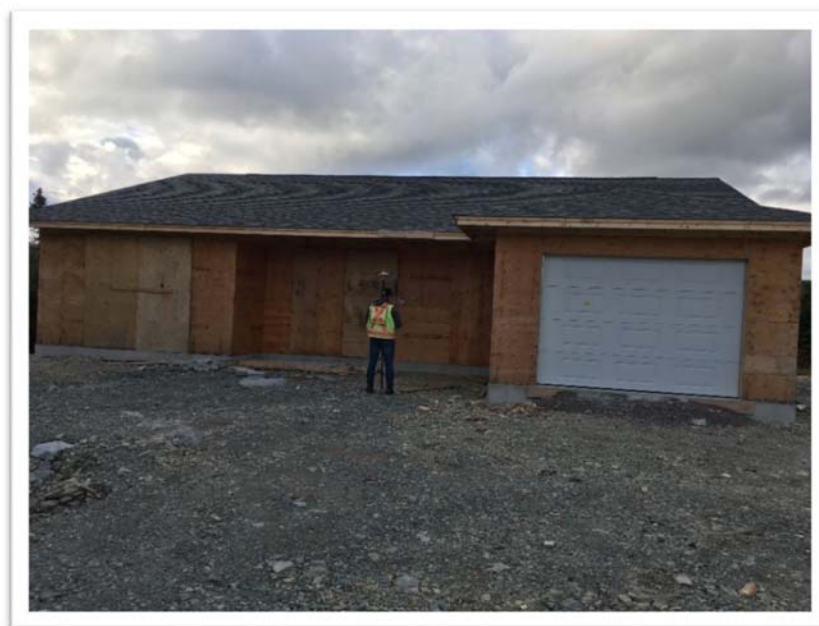
Figure 3: New House Located on Mahon's Lane

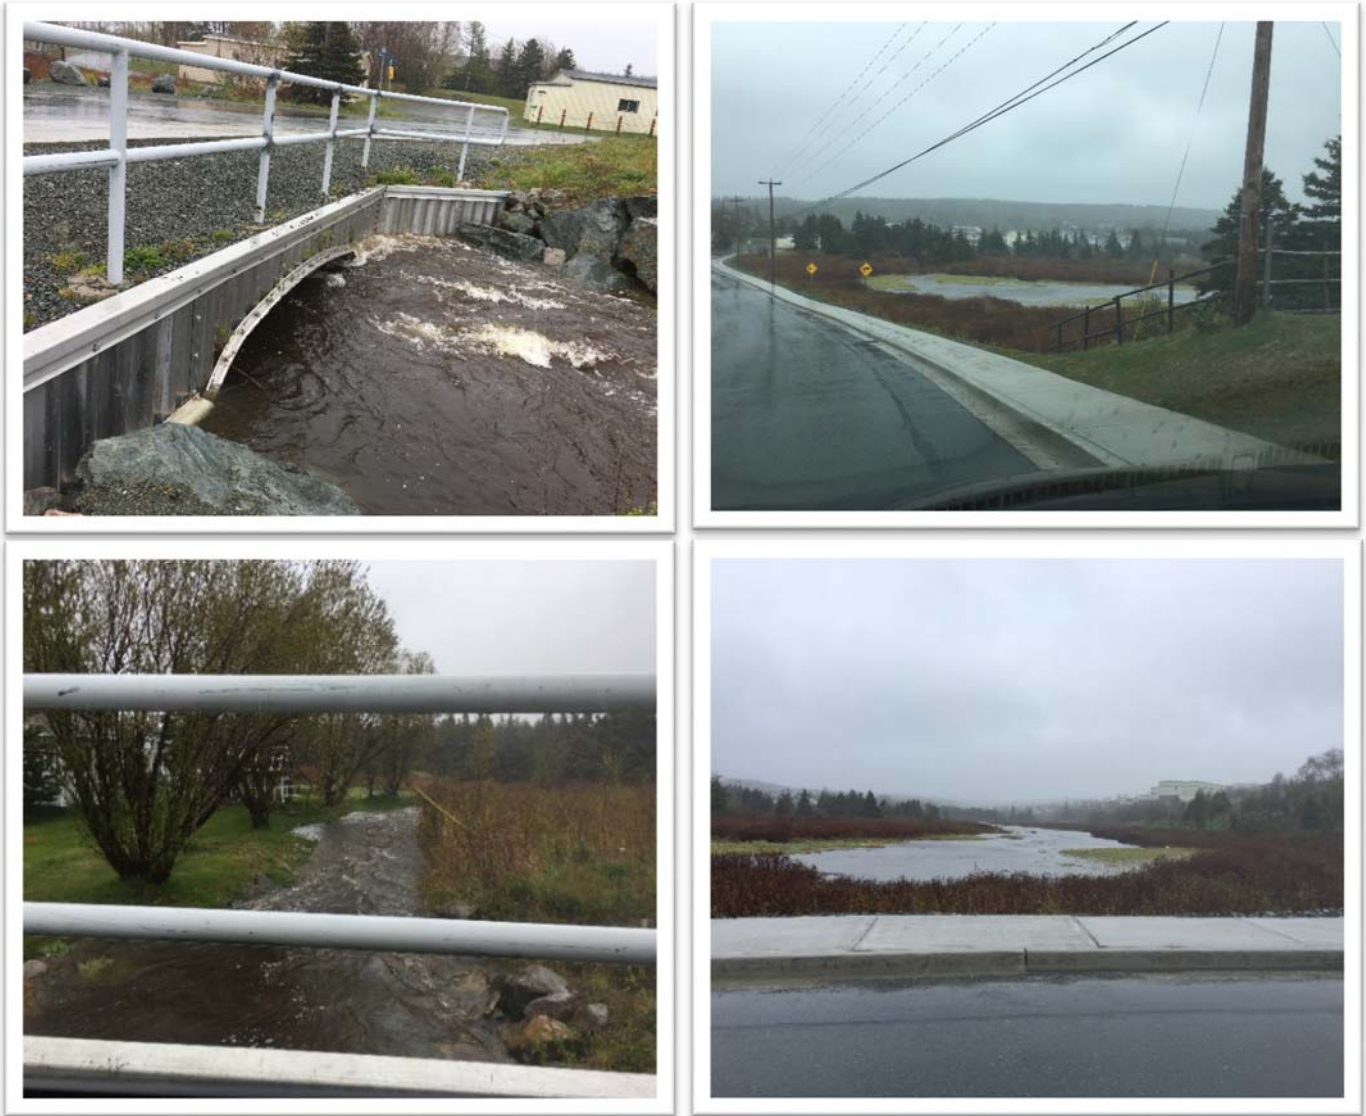
On May 30th, 2018, St. John’s and surrounding areas on the Avalon Peninsula experienced a major storm event that caused some infrastructure damage in surrounding areas. In the days that followed the storm events, meteorological data was gathered from Environment Canada and it was estimated that this rain event could be classified as a 2 to 5 year storm event. PEC staff travelled to Torbay to observe any potential flood prone areas, “The Gully” being one of them. It was observed that the existing arch bottomless culvert in the area was essentially at capacity and that the outlet stream was nearing capacity as well. The routing of the flow seemed to indicate that a lot of the flow was missing the culvert and hitting the aluminum headwall, instead of passing through the culvert.

The outlet stream appeared to be nearing capacity, however no flow was passing onto the adjacent property. There was not a tremendous amount of freeboard available on the stream, indicating that if a more severe storm event should occur, flooding may be a concern for the adjacent property.

The Gully itself was saturated with flow, and photographs taken that day indicate a large amount of runoff contained within “The Gully”

Figure 4: Photographs Taken on May 30, 2018

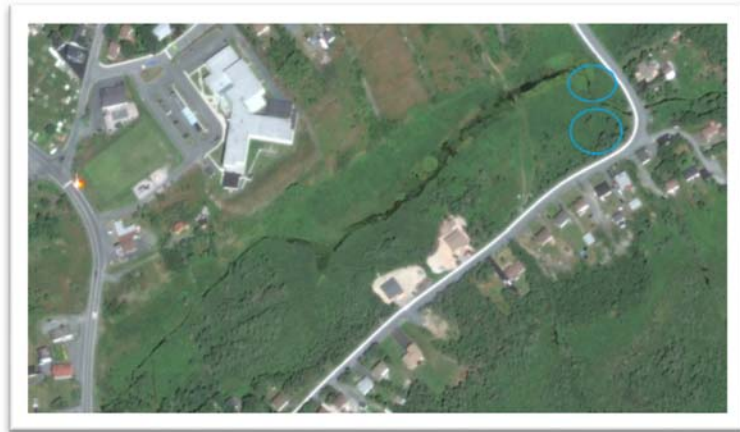
that the flow has a tendency to pond to the north west of the bottomless arch culvert located on Lynch’s Lane. This indicates that the small stream passing through “The Gully” reaches capacity at some point upstream of the arch culvert and begins to spill into the wetland located to the north west of the stream. As the storm events progressed, this water depth began to increase due to the increased amount of runoff entering the wetland. Eventually, this water depth matched the asphalt elevation depicted from the digital terrain model and began to flow across Lynch’s Lane. This occurred for all of the 100 year storm events. This location of ponding can be seen in the circles shown in figure 5

Figure 5: Location of Ponding in "The Gully"

The stream passing through "The Gully" lacks the capacity for the incoming flow. The sharp turn that the stream makes near the arch culvert likely results in flow spilling over into the surrounding wetland. This happens in several other locations as noted in the body of the report, meaning that during a storm event, not all of the flow will reach the culvert. Rerouting or deepening the existing stream that passes through "The Gully" is likely not an option because "The Gully" is a protected wetland area. Instead, by creating a berm that is of sufficient elevation would eliminate the risk of the flow from "The Gully" passing over Lynch's Lane and into the marsh area across the road. If a berm is to be constructed, it should be placed along Lynch's Lane and partially along Mahon's Lane to prevent any flow from exiting the wetland and onto the surrounding streets. Simply placing a berm along Lynch's Lane would result in containing the flow so that it begins to flow across Mahon's Lane. Creating a berm would result in deeper water elevations in "The Gully" but prevent any flow from entering the surrounding residential areas, essentially confining the storm runoff to the wetland and routing flow into the arch bottomless culvert. The placement of the berm can be seen by the red line in Appendix E. The berm should be designed so that the maximum water elevation seen during a storm event is two feet below the top of the berm. Based on the maximum water elevation identified at the location of the berm, it is recommended that the minimum berm height should be approximately 1.5 m

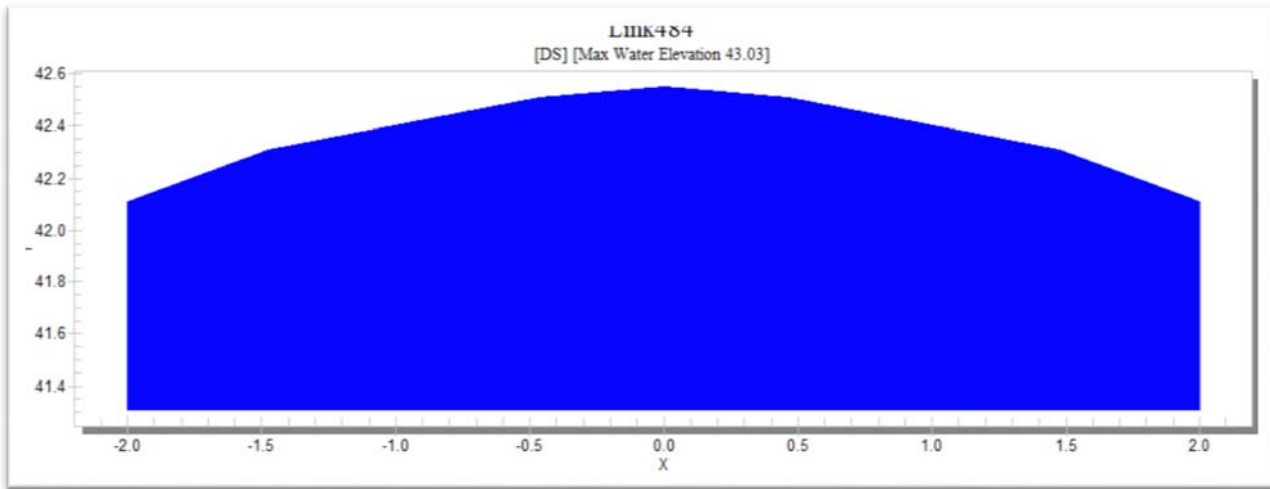
Aside from the fact that there was flooding present, the arch bottomless culvert on Lynch’s Lane was above capacity, even though some of the flow from the catchment was not being routed through the arch bottomless culvert. This indicates that for a 100 year storm event, the existing arch bottomless culvert is undersized. The extents of flooding can be seen in Appendix D while the culvert, which is at capacity can be seen in figure 6. Figure 6 shows a cross-section of the existing culvert at capacity during a 100 year storm event.

Figure 6: Existing Arch Bottomless Culvert at Capacity

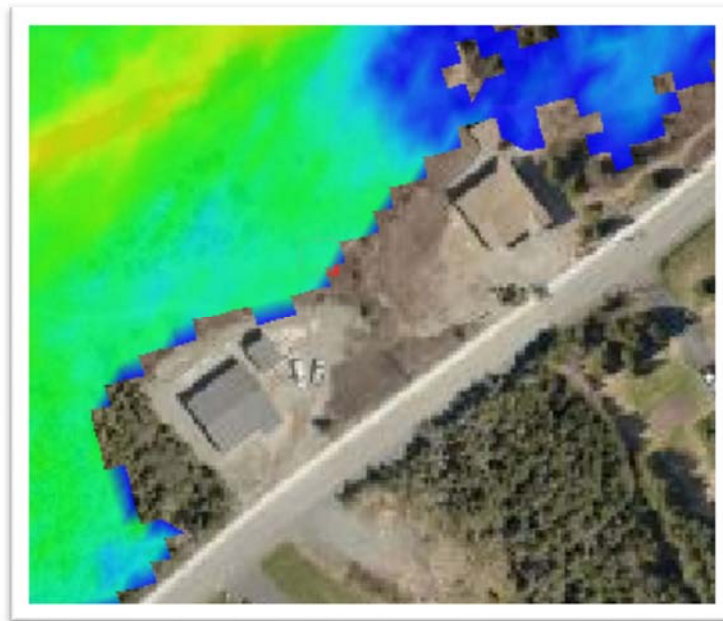
The maximum water elevations calculated at the two new homes on Mahon’s Lane during the worst storm event modeled are shown in figure 7 and are lower than the finish floor elevations of both these slab-on-grade houses. This figure shows how the approaching flow surrounds the new houses. None of the flow passes onto the fill areas, which are discussed earlier in the report, therefore the water does not reach a depth that matches the elevation of these houses, meaning no flooding occurs. That being said, the elevations shown in the figure below indicate high water depths of water near the new homes, approaching 1.0m near the new homes. The maximum

water velocity at this location is approximately 0.2m/s. Given the high water depth at this location, combined with that velocity, there exists some risk to human safety in the event that someone should fall into the water at this particular location. The velocity is not excessively high, most likely due to the high amount of vegetation in the area which in turn creates higher water depth from ponding but lower water velocity due to increased roughness.

Figure 7: Maximum Water Elevations Surrounding Houses

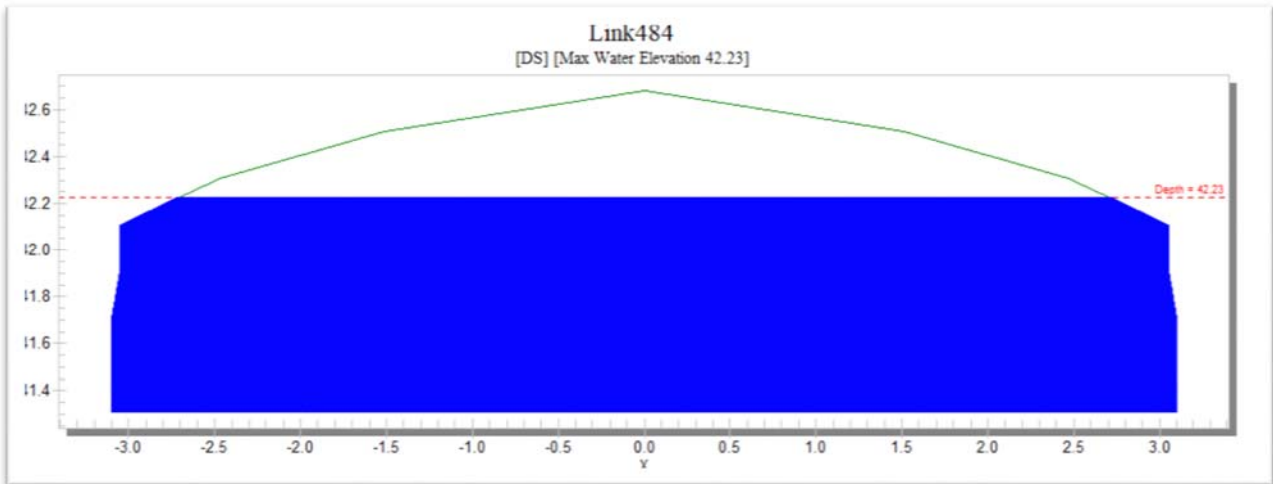
Replacing the existing arch bottomless culvert is necessary to mitigate the risk for flooding during a 100 year storm event. Replacement of the culvert is limited by the amount of available cover on the culvert, as well as the proximity of the adjacent properties. A list of potential geometries that could be installed in this area was reviewed with local suppliers. A 6.198m x 1.372m span arch bottomless culvert could work. The new culvert size was entered into the model. The combination of the upsized culvert and altered outlet stream provided satisfactory results. The worst storm event, in terms of total flow passing through the culvert was the 100 year 6 hour storm. In this event the culvert was at capacity, but the water level was still below the elevation of Lynch's Lane, thus no flooding occurred. A cross-section of the new culvert at peak flow during a 100 year 6 hour storm can be observed in the figure below

Figure 8: Upsized Culvert - 100 Year 6 Hour Storm

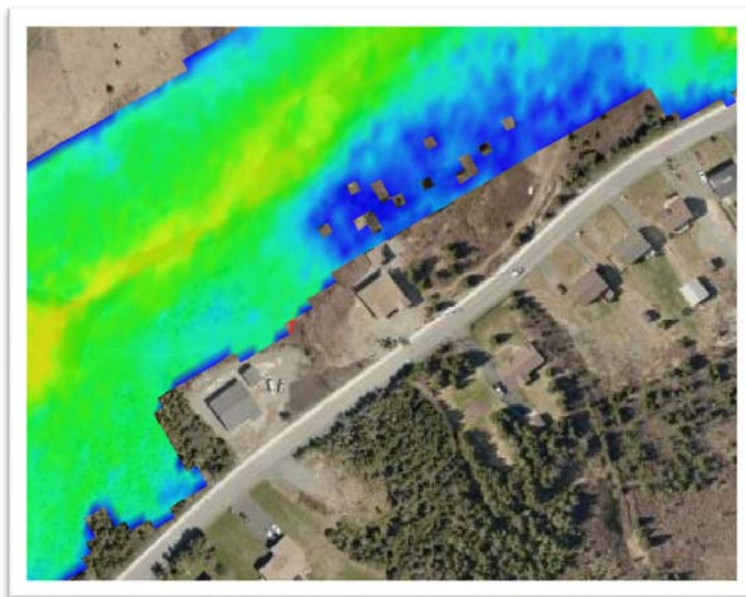
Returning to the slab on grade houses that have been constructed on Mahon’s Lane and the future building lots to be constructed in the area, the placement of a berm in the model results in higher water depths near these houses, but still no flooding. For protection, the berm could be continued behind these houses to ensure no flooding occurs. This is seen in Figure 9.

Figure 9: Water Depths at New Properties & Building Lots (Mahon’s Lane)

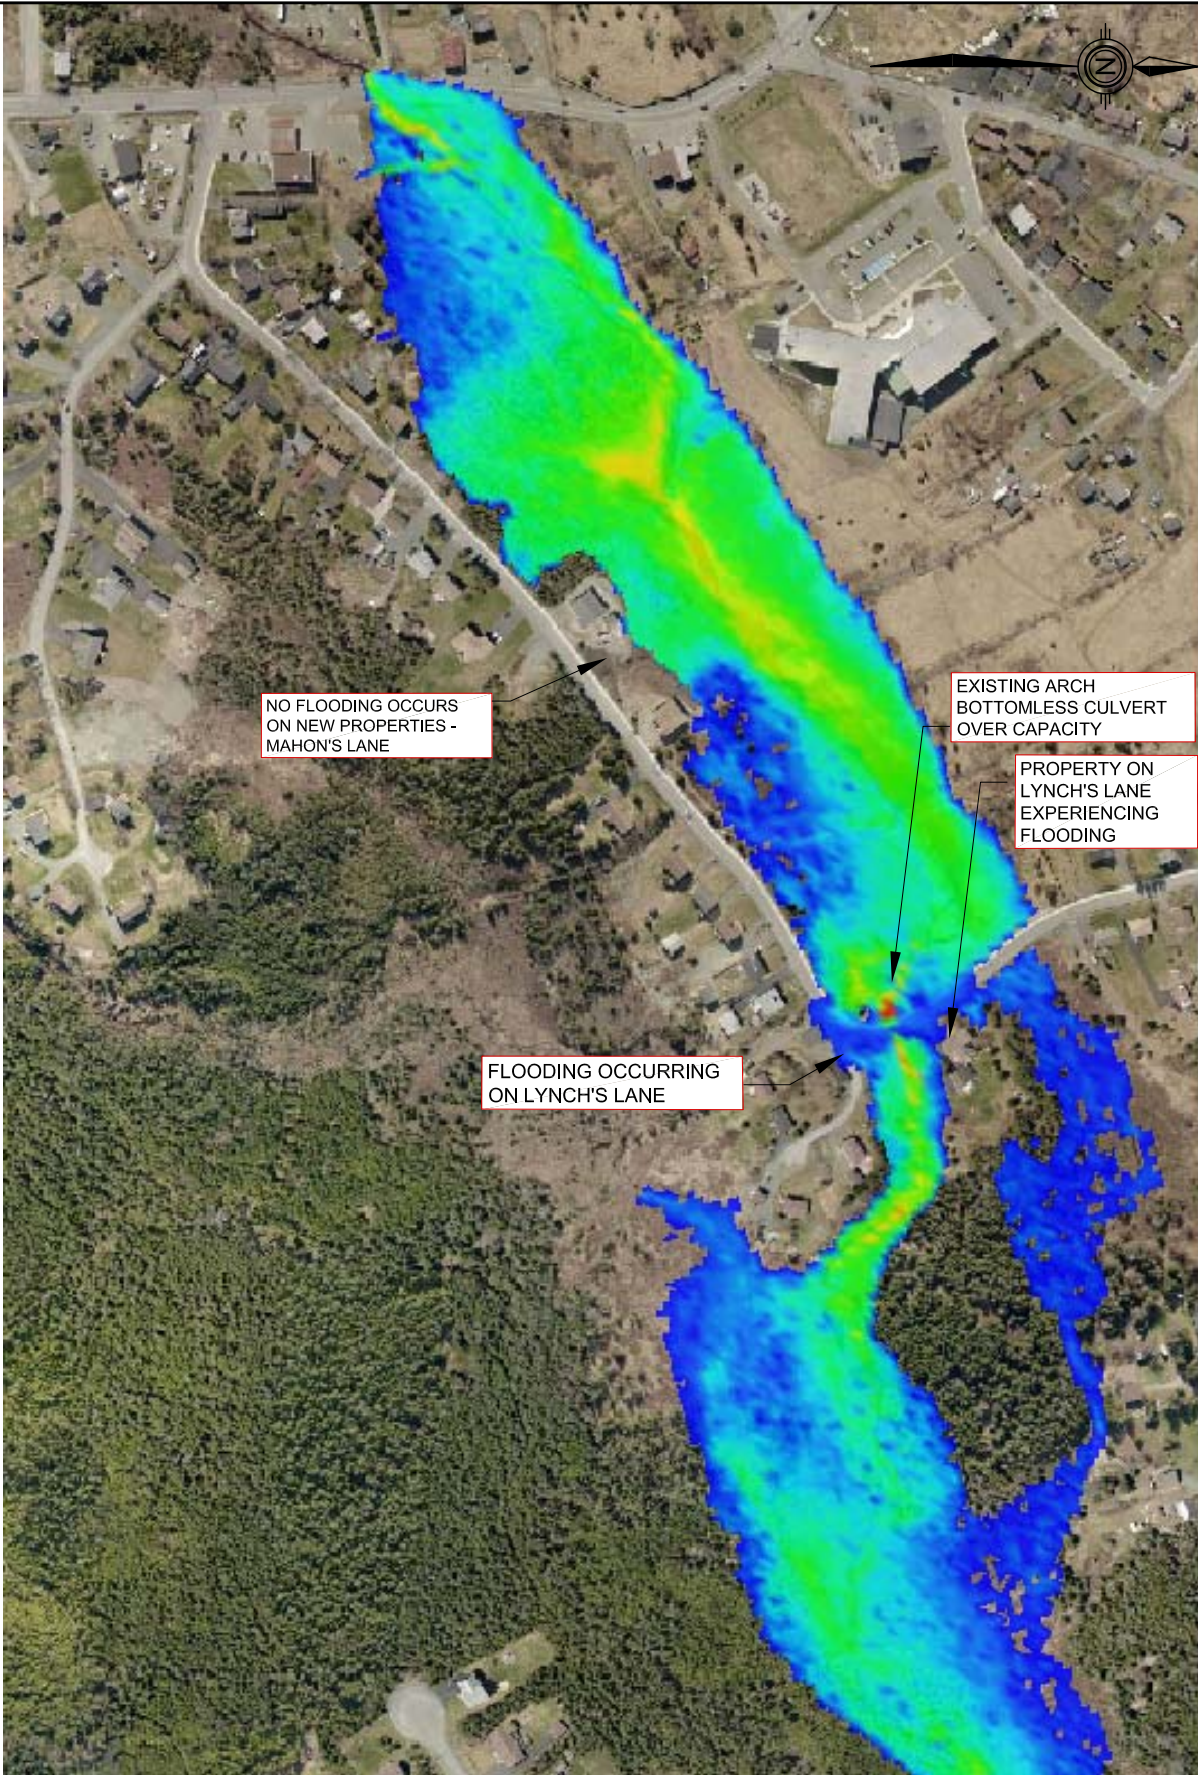
DRAWING TITLE: PRE-UPGRADES FLOODPLAIN

From the maximum extents of flooding, it is evident that there is the potential for property damage occurring to civic # 23 on Lynch’s Lane, due to both the extent of the floodplain as well as the low elevation of the property relative to the surrounding wetland.

These results indicate two problems associated with the existing system. The existing elevation of Lynch’s Lane is too low relative to The Gully. According to the XPSWMM model, when a major storm event occurs, The Gully will experience significant ponding of water until this water depth reaches the elevation of the road where it will then spill on to the existing road, potentially causing significant damage to the road and private property. Another issue is that the existing arch culvert is unable to handle the amount of flow entering and leaving the Gully. The stream exiting The Gully also very little additional capacity, especially given the high volume of flow modelled during a 100 year storm event.

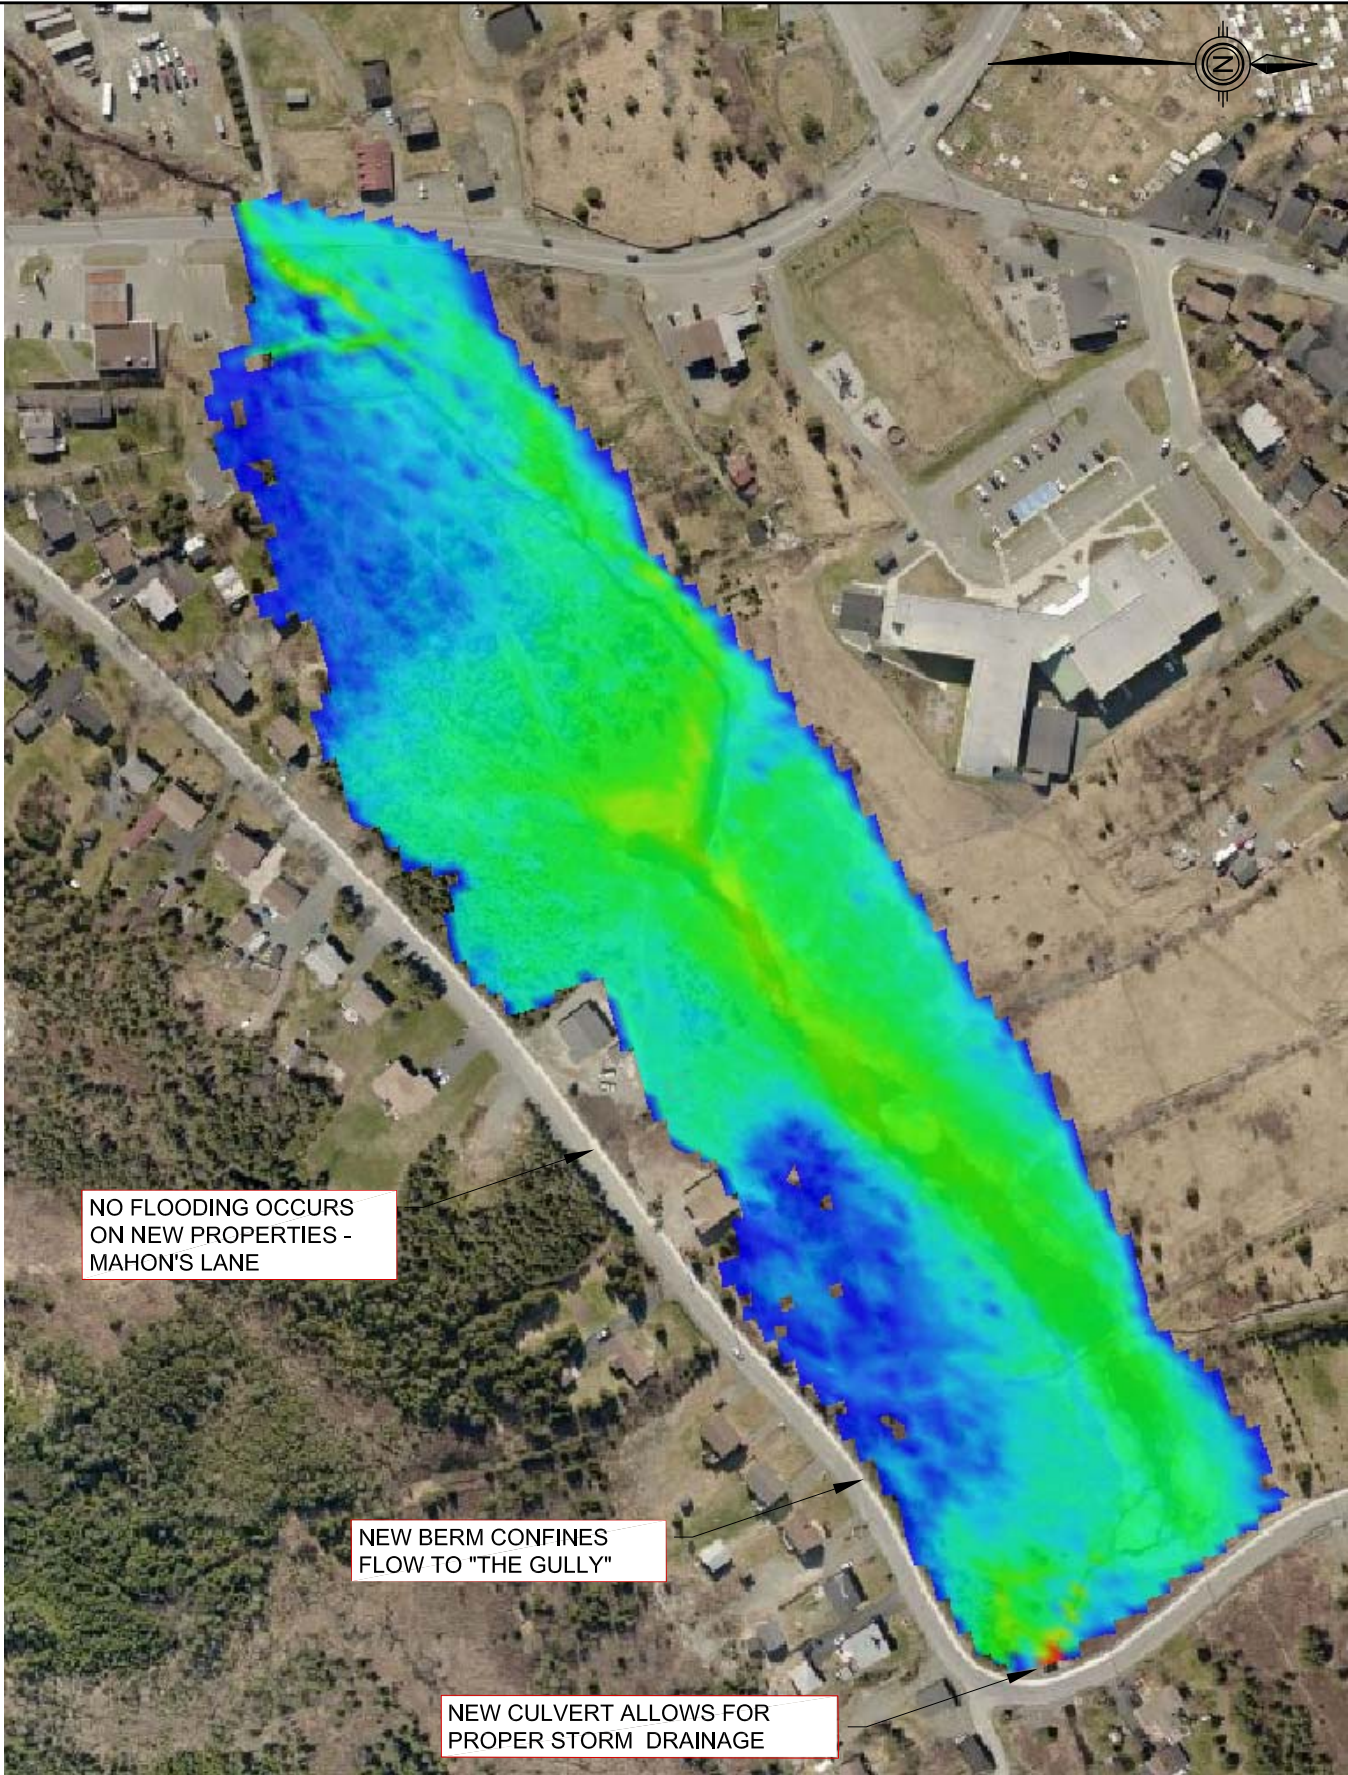
DRAWING TITLE: POST UPGRADES FLOODPLAIN

Revising the model to include the larger culvert at Lynch’s Lane and the berm yielded a new floodplain. Shown in Appendix F, the new extents of flooding is confined to the wetland itself and there is no flooding observed on Lynch’s Lane or Mahon’s Lane.

NO FLOODING OCCURS
ON NEW PROPERTIES -
MAHON'S LANE

NEW BERM CONFINES
FLOW TO "THE GULLY"

NEW CULVERT ALLOWS FOR
PROPER STORM DRAINAGE
