# Torbay – Stormwater Management Plan

## Town of Torbay, NL

June 20, 2019

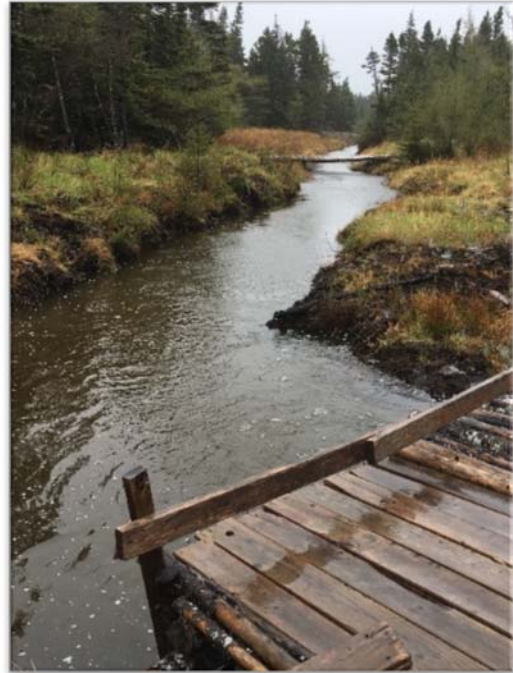
**Figure 3: Skipper's Landing Cutoff Drainage Ditch**

Residents have expressed concern with this cutoff ditch, stating that the majority of overland flow issues are a result of the ditch becoming full and passing onto their properties, or potentially flooding their basements. From the cutoff ditch, the runoff is conveyed through a 600mm and a 700mm CSP culverts. These culverts are shown in Figure 4.

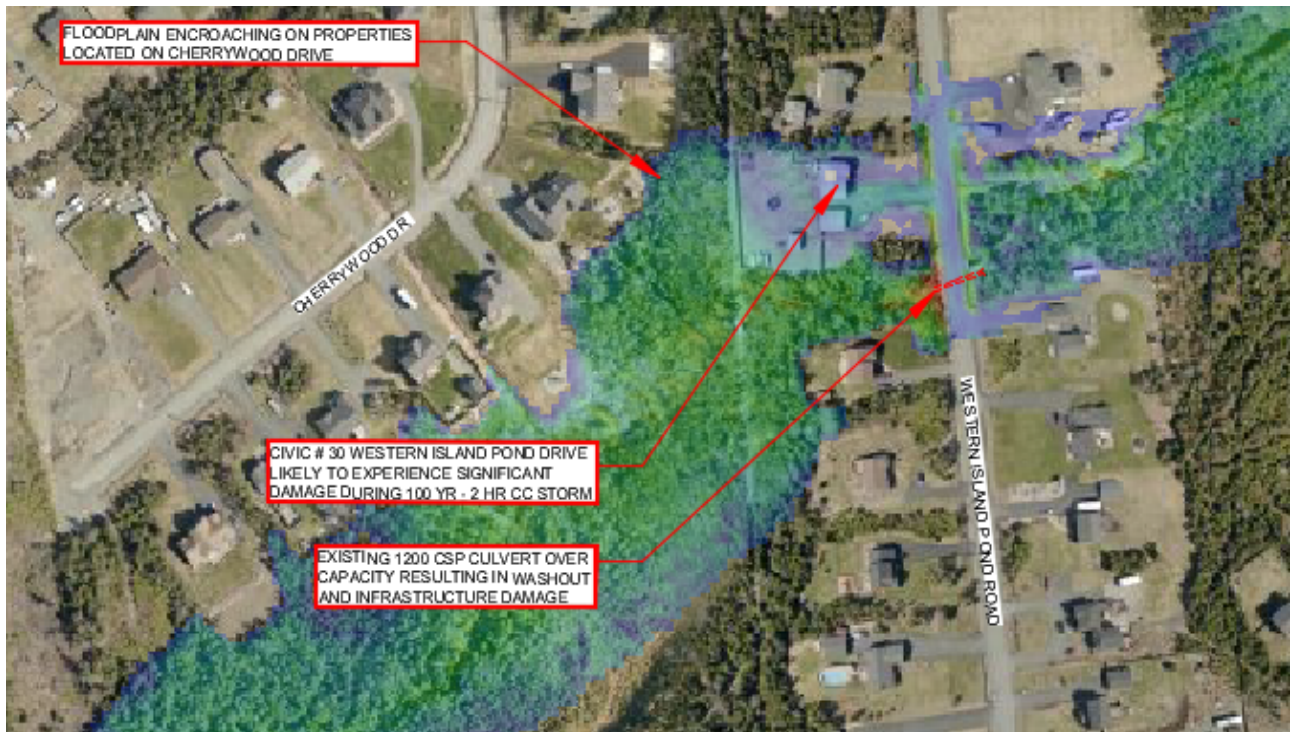
actually lower than the cutoff ditch itself. This would cause ground water surrounding these homes to rise above their basement elevations resulting in flooding. Flooding in this area has been ongoing and this existing conditions model further supports what has been witnessed.. Upon leaving the immediate area of Skipper’s Landing, the storm water is conveyed through a wooded marshy area. It then encounters a property located on Civic #30 Western Island Pond Road that is located in a depression in the topography. As a result, there is a significant buildup of runoff at this property that could potentially result in significant private property and infrastructure damage. The culverts crossing Western Island Pond Drive also appear to be under capacity and as a result, flooding occurs on this property. There is also overland flow across this portion of the street as shown in Figure 6 below.

**Figure 6: House Flooding on Civic #30 Western Island Pond Road Indicating Direction of Flow**

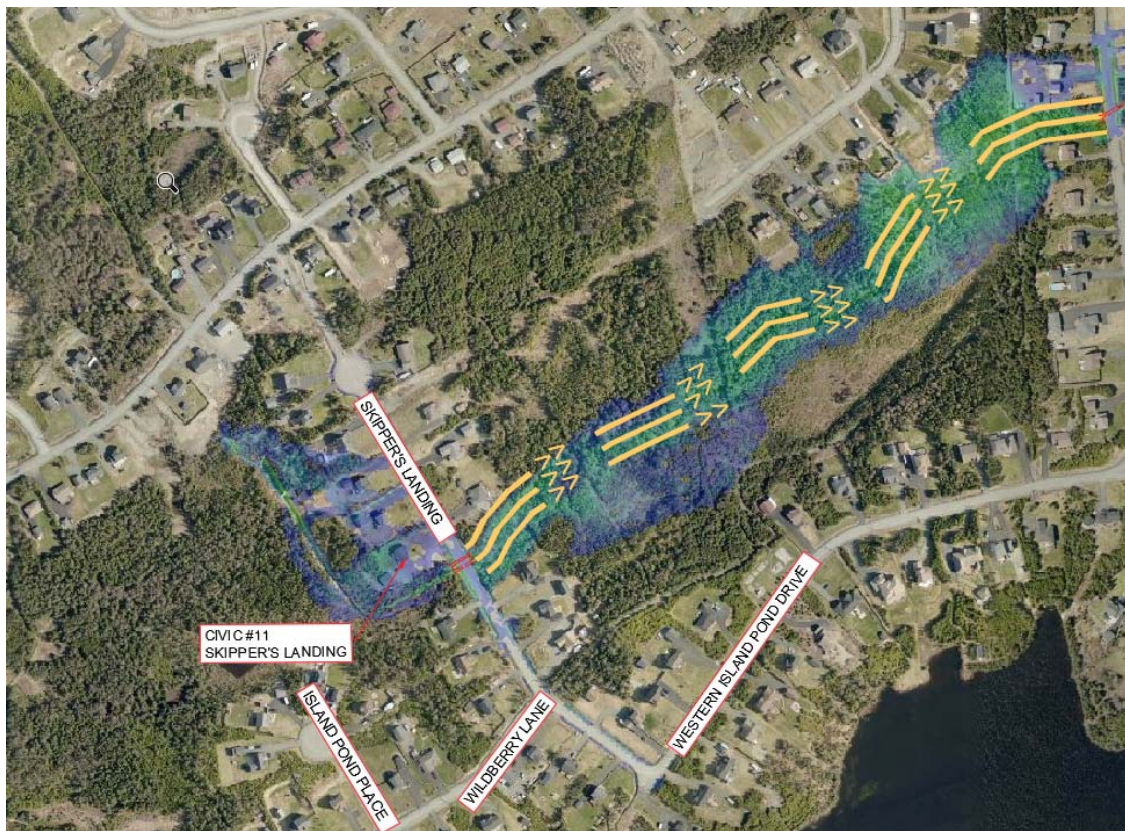
Analyzing the floodplains in Appendix E, it is evident that the 100 Yr – 12 Hr storm has the biggest impact on infrastructure. The twin culverts passing through Skipper’s Landing and the larger culvert on Western Island Pond Drive are under capacity and flooding is observed on both of these streets. The cutoff ditch becomes full and significant overland flow and flooding can be observed on the properties on the western side of Skipper’s Landing. The above issues can be observed in the figure below as well as Appendices E and F.

Figure 7: Skipper's Landing Floodplain 100 Yr - 12 Hr CC

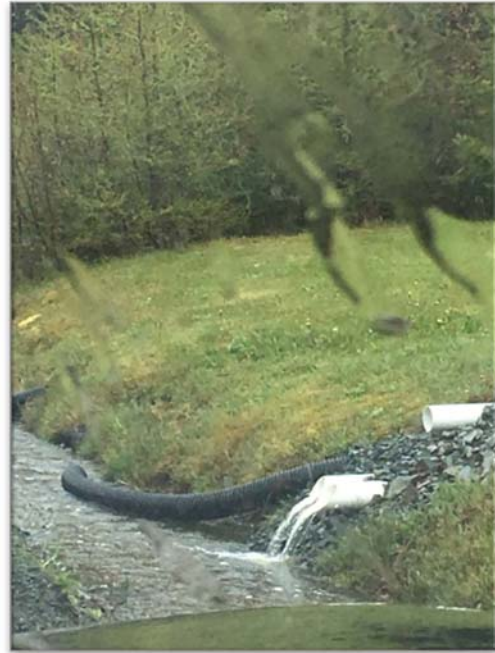
These model results are not unlike what has been observed by residents and Town representatives. Specifically, Civic # 11 on Skipper’s Landing has had severe drainage issues. The XPSWMM model under existing conditions shows that this residence is the first to experience overland flooding issues. Figure 8 is a photograph showing the amount of weeping tile and amount of runoff being carried away from the property during the May 30<sup>th</sup> 2018 rainstorm.

**Figure 8: Weeping Tile - Civic #11 Skippers Landing**

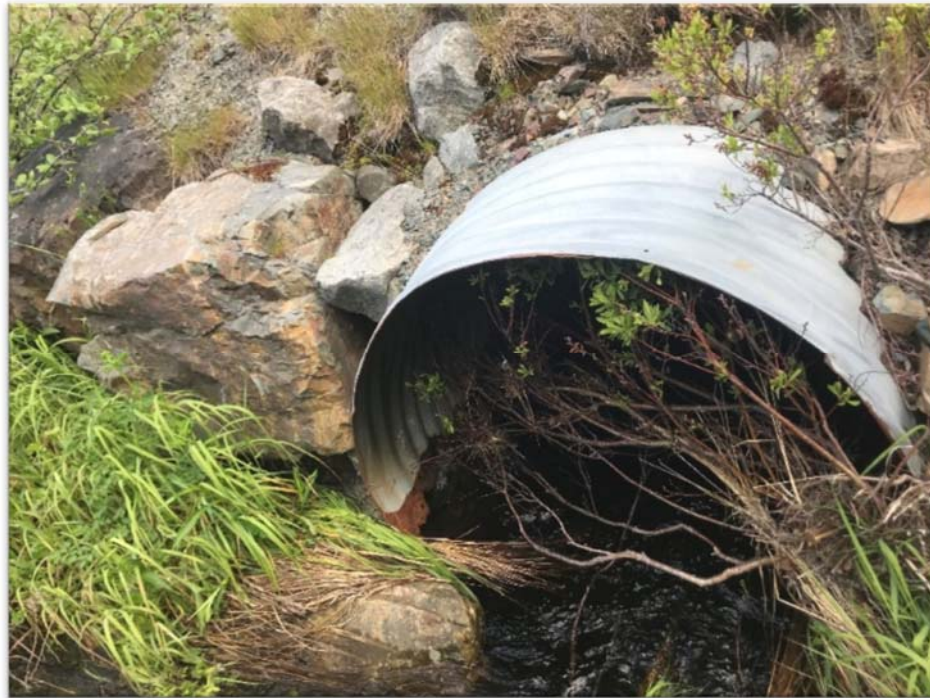
Bauline at low Points To convey runoff across the road. This structure has been upgraded in recent years and as a result is in good structural condition with little debris in the upstream and downstream inverts. Moving downstream of this bridge structure, the runoff passes through a 1400 and a 1000mm culvert which pass through Middle Three Island Pond Road, a gravel road with no residential or commercial areas nearby. There is also a large 2700mm diameter CSP culvert that conveys runoff from Great Pond and to the other side of Bauline Line. This structure can be observed in the Figure 10.

**Figure 10: 2700 CSP - Bauline Line**

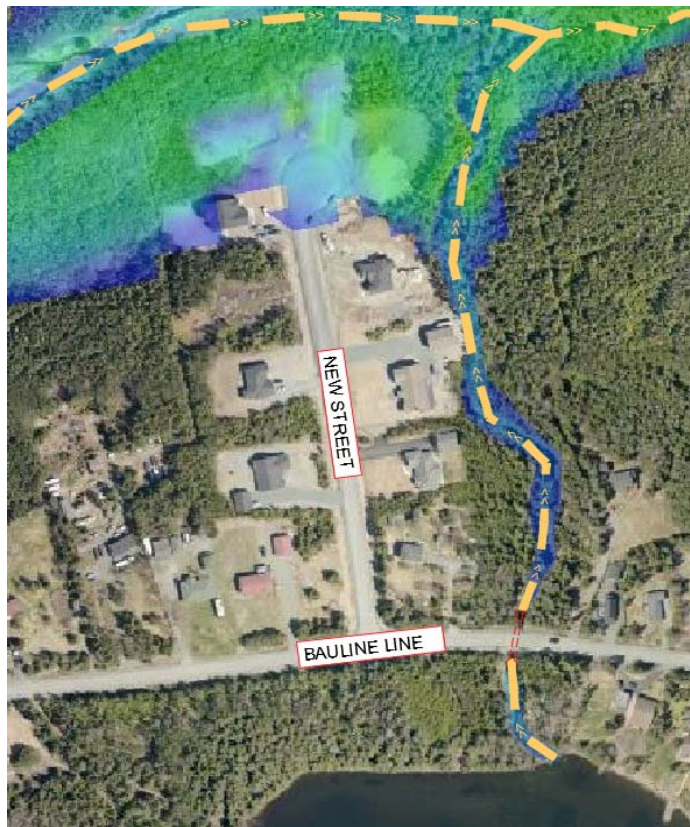
Shown in Appendix E is a map of the floodplain showing the extents of flooding under existing conditions. The culverts crossing the gravel Middle Three Island Pond Road are under capacity as well as the twin CSP culverts crossing Bauline Road near the soccer field and baseball field complex. One area of potential property damage that is observed in the floodplain of the 100 Year 6 hour storm is the newly constructed “New Street” For this particular storm event the storm runoff overtops the banks of the river located behind this property and passes onto some properties located on “New Street”.

**Figure 12: Flooding Observed on Middle Three Island Pond Road - 100 Yr - 24 Hr CC**

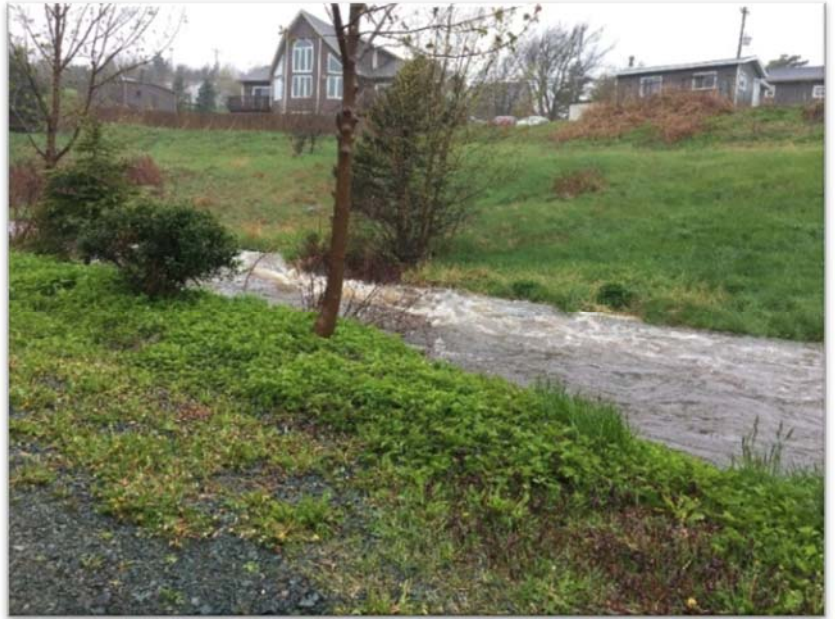
**Figure 14: Stream Approaching Capacity During Heavy Rainfall Event**

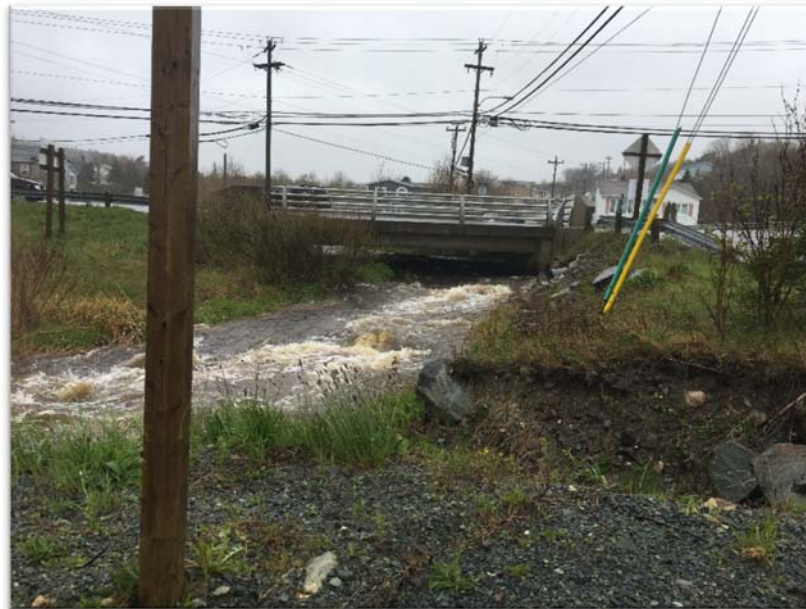
runoff from the rest of the catchment. The elevation of the home is very similar to the upstream elevation of the stream, meaning that if runoff should pass over the banks of the stream, a significant volume of runoff would likely pass onto the property and has in the past. Further downstream from this area, the runoff passes underneath a major bridge structure that crosses Torbay Road. This piece of infrastructure was observed to have a large amount of freeboard during the intense rainfall event in May of 2018

**Figure 17: Bridge Structure - Torbay Road during May 30, 2018 Storm Event**

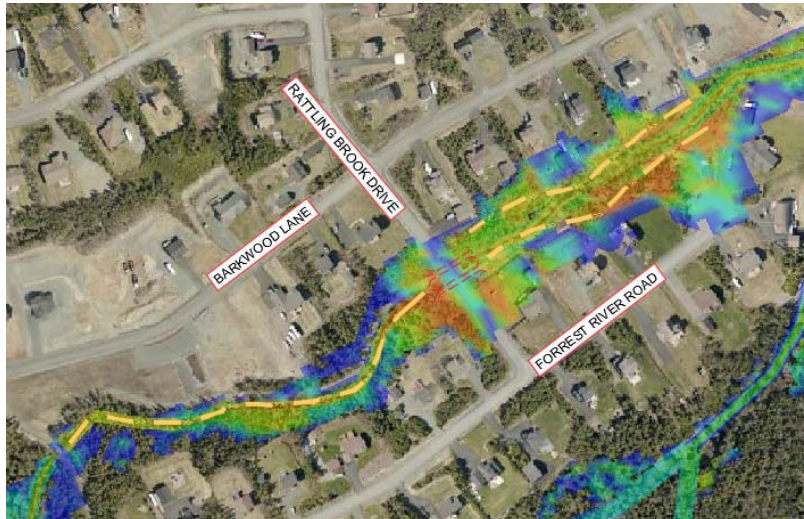
The most severe storm for this catchment area is the 100 year 2 hour storm. The floodplain for the large Island Pond Brook catchment can be observed in Appendix E One area of concern is in the area of Rattling Brook Road . Near the inlet of the twin 1500 CSP culverts on this street, the stream becomes very flat

**Figure 18: Flooding Occurring on Rattling Brook Road & Properties  
100 Yr – 2 Hr CC**

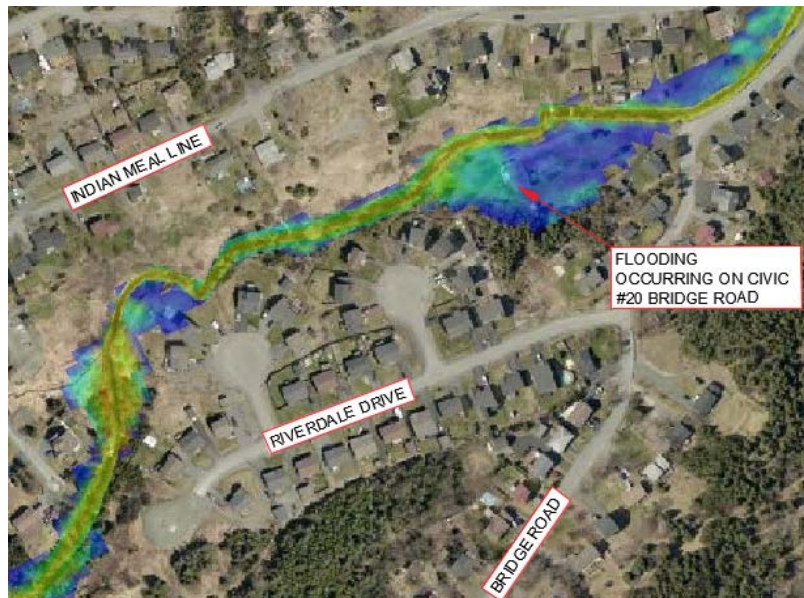
**Figure 19: Flooding Occurring on Civic #20 Bridge Road 100 Yr – 2 Hr CC**

can also be observed in Figure 19. At this point in the stream the slope and capacity of stream is too little and the flow begins to pass over its banks and make its way onto this property as well as some of the surrounding properties. The elevations taken from the LIDAR suggest that the homes near this stream are near the elevation of the stream.

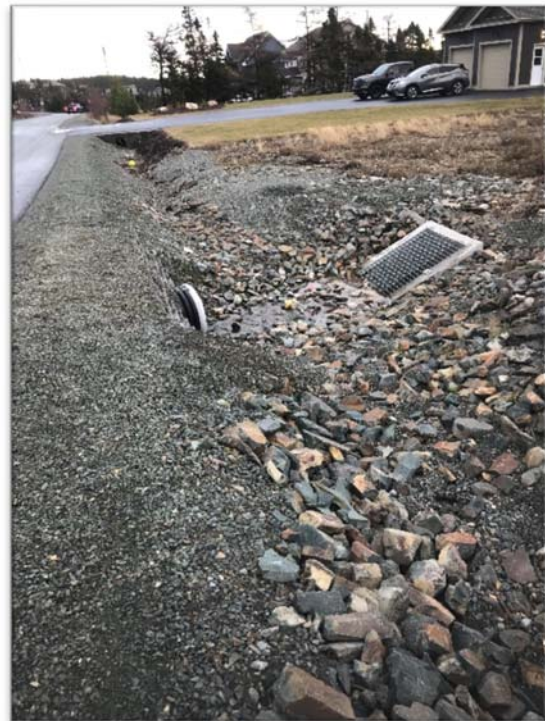
**Figure 20: Detention System - Barkwood Lane**

These stones should be higher than the shouldering as the runoff from the asphalt is eroding the shouldering. Also, a solution of either extending the headwall or extending the riprap up the sides of the ditch should also be considered as the runoff from the street is eroding the shouldering in this area and depositing silt and sand in the inlet of the storm detention system.

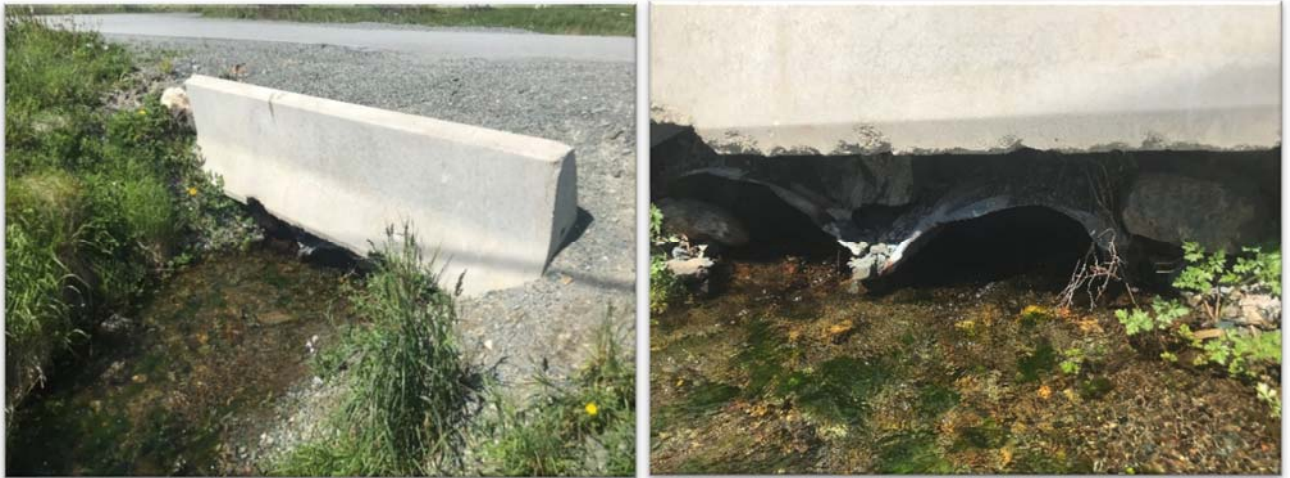
**Figure 21: Concrete Barrier Compressing Culverts - Cannon Marsh Road**

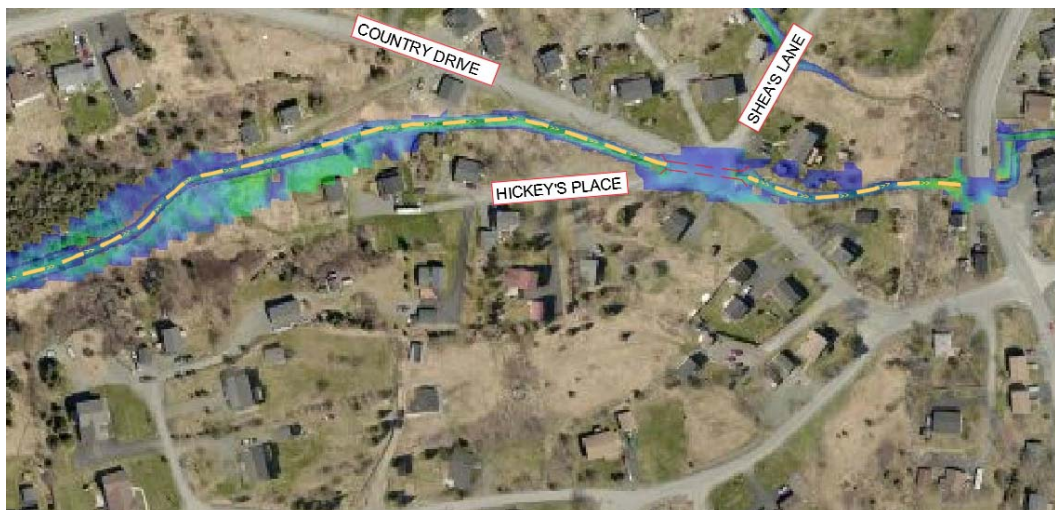
In the Whiteway Pond catchment area there are several areas of concern upon running 100 year simulations. The worst observable storm that was modelled was the 100 year 24 hour storm. In particular, in the area of cannon marsh road, the natural stream becomes very flat and as a result the twin culverts crossing the road become overwhelmed and the model shows that there is currently flooding. This does not take into account that in the field, it was observed that a concrete barrier is compressing the outlet side of the culverts. This means that in a real world scenario, if the 100 year climate change storm were to occur, it most likely result in worse flooding than observed in the model. This is shown in Figure 22:

**Figure 23: Flooding Occurring Near Hickey's Lane, Intersection of Country Drive/Hickey's Lane 100 Yr - 24 Hr CC**

In the area of Hickey's Lane, the natural stream passing adjacent to Hickey's Lane appears to be at capacity and overland flow can be observed on the properties of nearby homes. The low capacity of this natural stream also allows poor conveyance through the existing 900mm CSP culvert, resulting in a potential washout in this intersection. By constructing a berm along the stream it confines the flow to the stream itself preventing overland flow and allowing for proper drainage through the 900mm CSP culvert, preventing property and infrastructure damage and prevents having to replace the existing culvert. This berm should be constructed at a minimum height of 1.2m with side slopes of 2 to 1.

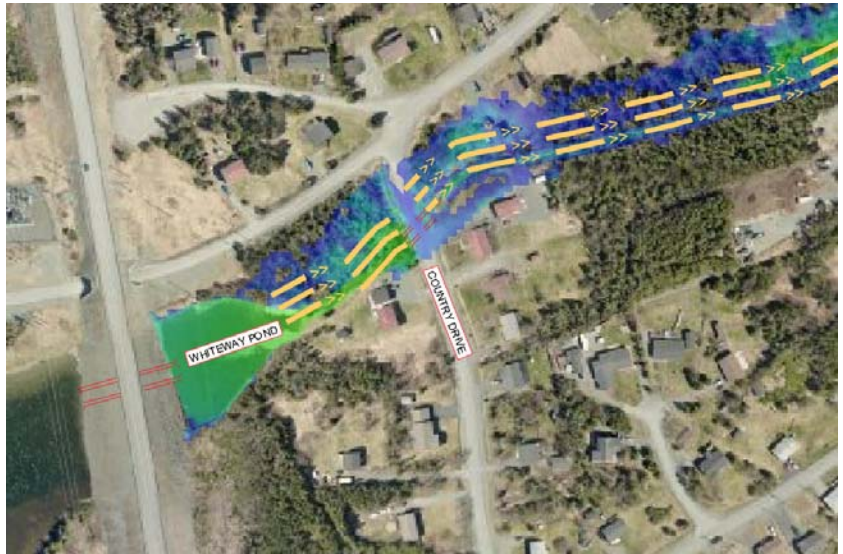
Runoff leaving Whiteway Pond must pass through 600mm twin CSP culverts crossing country road. Running the 100 year climate change storms indicates that flooding will occur on this street during the 12 hour and 24 hour storm events. Directly downstream from Country Drive, the existing 1200mm CSP culvert on Russworthy Place is also under capacity resulting in flooding.

**Figure 24: Twin Culverts - Country Drive Under Capacity**

Given the significance of infrastructure damage if this event were to occur, it is recommended that these twin 600mm CSP culverts be replaced with twin 800 CSP culverts. Shown below is a before and after figure showing the extents of flooding prior to replacing these damaged culverts and no modifications to the existing stream.

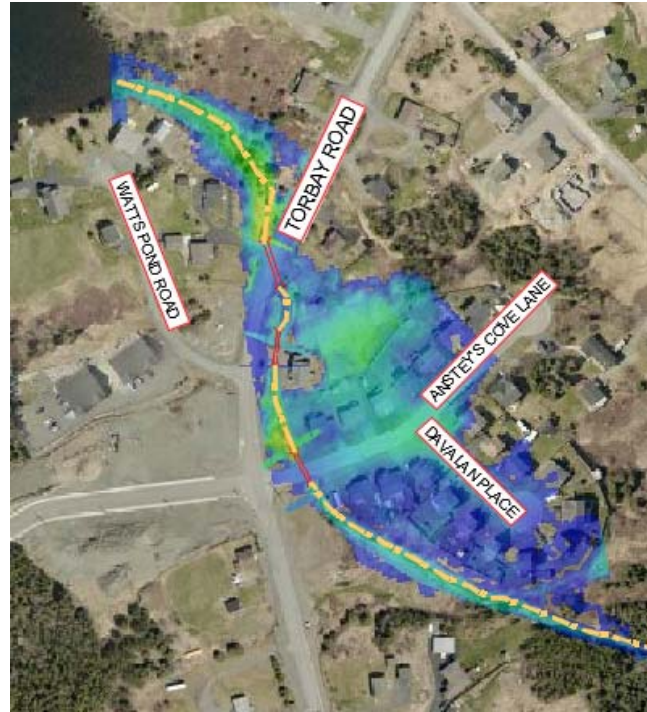
When modelling the updated climate change storms it appears that there still exists the potential for flooding in this area. Runoff appears to be passing behind the berm and then accessing Anstey's Cove Lane and causing major flooding in that particular area. The stream located downstream has sufficient capacity to carry the amount of runoff from these major storm events, but

**Figure 26: Flooding in the Anstey's Cove Lane Area 100 Yr - 24 Hr CC**

according to the model it is not properly receiving the runoff because of issues upstream. This flooding can be observed in the Figure 26

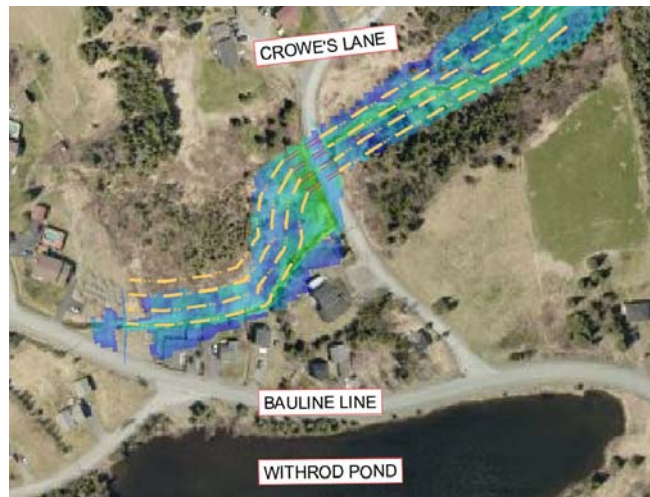
The area of Crowe's Lane area also has some flooding issues that are observed in the three culverts of diameter 600mm and fourth culvert of diameter 900mm were implemented to provide proper drainage between two wetland areas. Running the 100 year climate change storms indicates that if this particular storm event were to occur another washout may occur as all four pieces of infrastructure are under capacity

**Figure 27: Flooding Occurring on Crowe's Lane 100 Yr - 24 Hr CC**

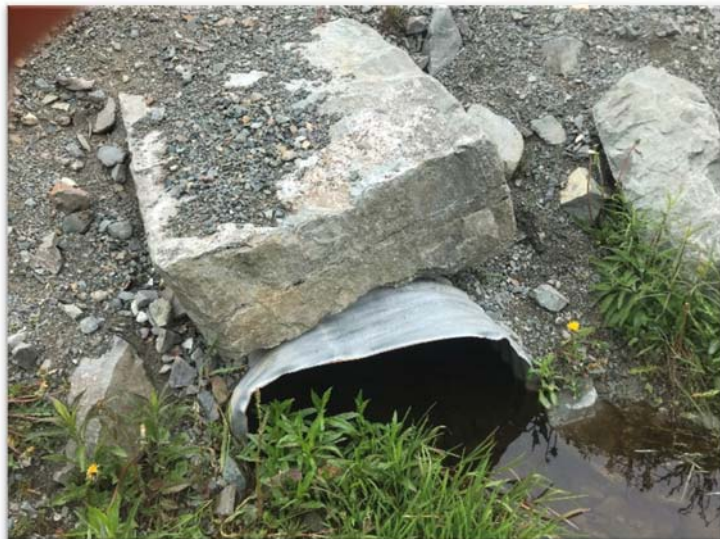
The runoff from this catchment area meanders through the residential area of Karon Drive and Pine Ridge crescent, crossing streets through local culvert structures. This runoff is conveyed across a 2000mm CSP culvert on Torbay Road, shown in Figure 28. Upstream from this large CSP culvert, a 900mm culvert crosses Rosebud Street which appears to be partially compressed by a large rock, shown in Figure 29.

**Figure 29: Rock Compressing Culvert - Rosebud Street**

This will reduce the capacity of the culvert and should be removed and the existing culvert should be replaced according to the recommendations made later in this report.

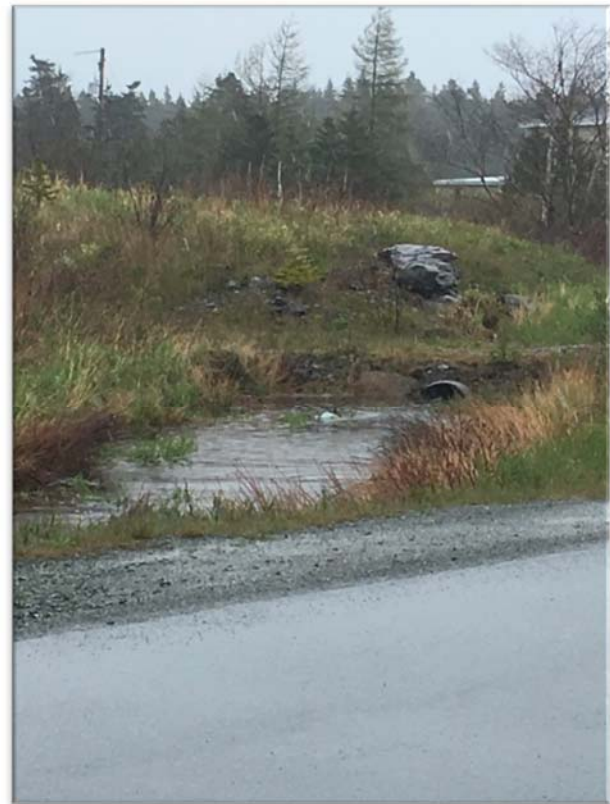
Figure 46: Ditch at Capacity - Bauline Line
