# Torbay – Stormwater Management Plan

## Town of Torbay, NL

June 20, 2019

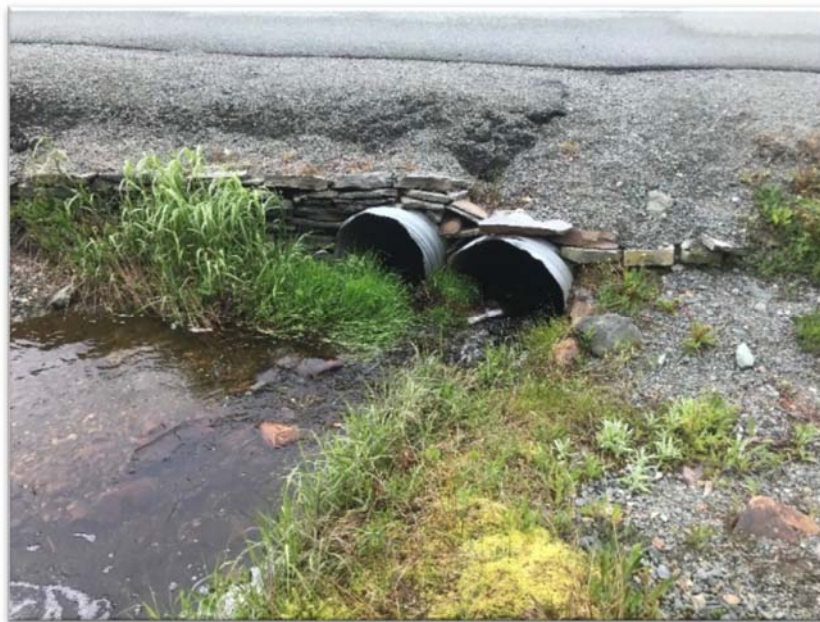
**Figure 4: 600 & 700mm CSP Culverts - Skipper's Landing**

Residents have expressed concern with this cutoff ditch, stating that the majority of overland flow issues are a result of the ditch becoming full and passing onto their properties, or potentially flooding their basements. From the cutoff ditch, the runoff is conveyed through a 600mm and a 700mm CSP culverts. These culverts are shown in Figure 4.

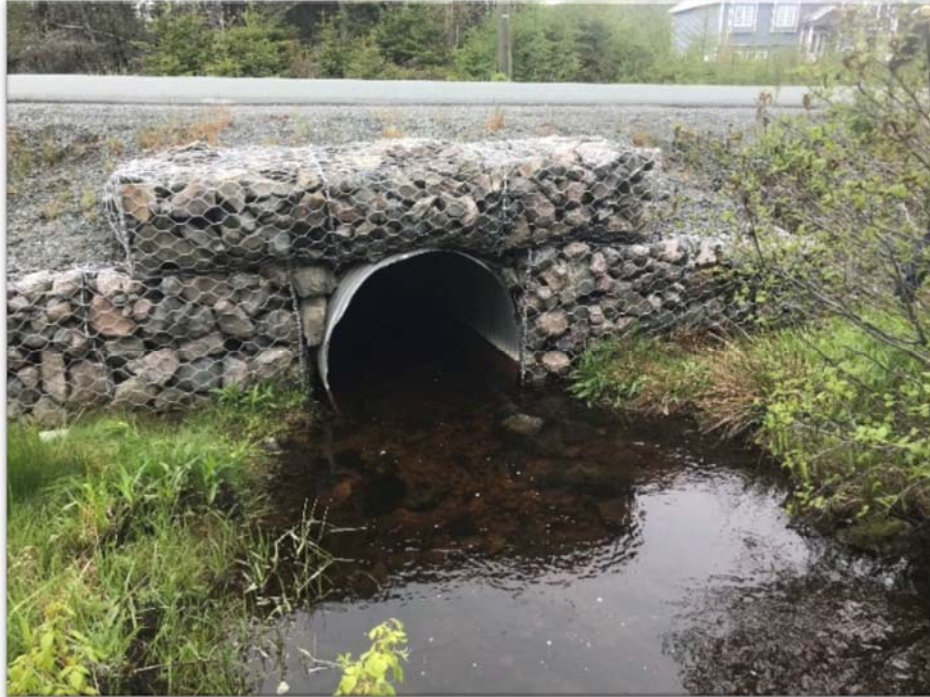
**Figure 5: Existing 1200 CSP Culvert Western Island Pond Drive**

Beyond these two culverts the runoff follows a natural stream through a marshy area at the rear of the homes located on the eastern portion of Skipper’s Landing where it eventually passes through a 1200mm culvert on Western Island Pond Road, as shown on Figure 5.

Analyzing the floodplains in Appendix E, it is evident that the 100 Yr – 12 Hr storm has the biggest impact on infrastructure. The twin culverts passing through Skipper’s Landing and the larger culvert on Western Island Pond Drive are under capacity and flooding is observed on both of these streets. The cutoff ditch becomes full and significant overland flow and flooding can be observed on the properties on the western side of Skipper’s Landing. The above issues can be observed in the figure below as well as Appendices E and F.

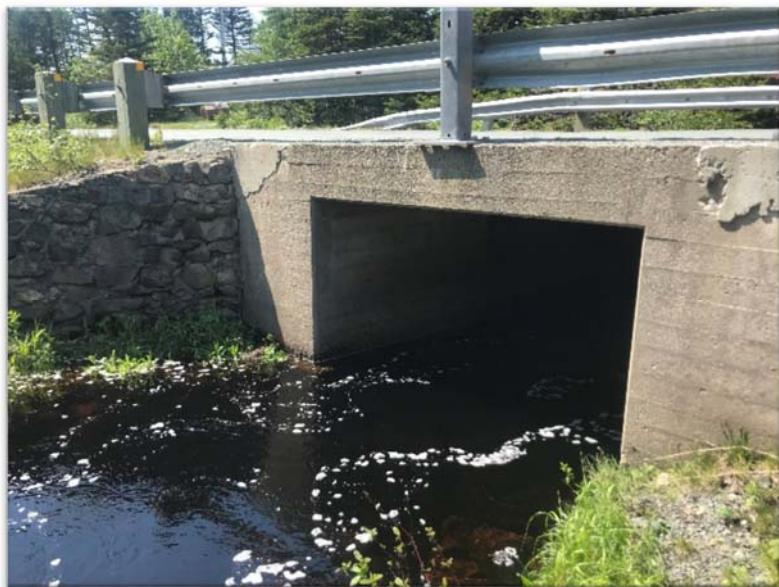
**Figure 9: Concrete Bridge Structure - Bauline Line**

Several natural rivers or streams convey runoff through the large catchment area. As a result there are number of pieces of key infrastructure located in this portion of the town, most notably is the concrete bridge structure located on Bauline Line as shown in Figure 9.

Bauline at low Points To convey runoff across the road. This structure has been upgraded in recent years and as a result is in good structural condition with little debris in the upstream and downstream inverts. Moving downstream of this bridge structure, the runoff passes through a 1400 and a 1000mm culvert which pass through Middle Three Island Pond Road, a gravel road with no residential or commercial areas nearby. There is also a large 2700mm diameter CSP culvert that conveys runoff from Great Pond and to the other side of Bauline Line. This structure can be observed in the Figure 10.

The bridge structure on Bauline Line has lots of capacity during the 100 year 24 hour storm event.

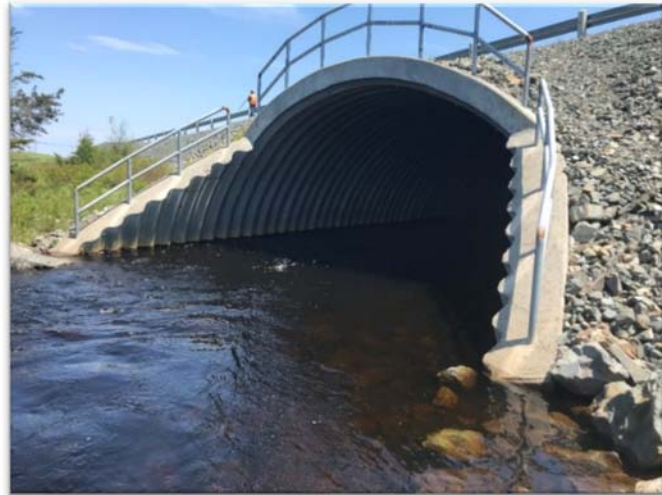
**Figure 11: Large Culvert Structure - Torbay Bypass Road**

The majority of the runoff in this catchment is conveyed to a wooded/marshy area behind properties located on Bauline Line through several small culvert structures. That cross Bauline Line. From this marshy area, the runoff is conveyed through a massive structure, which measures approximately 6.7m x 4.6m on the Torbay Bypass Road and is then flows into the town of Flatrock

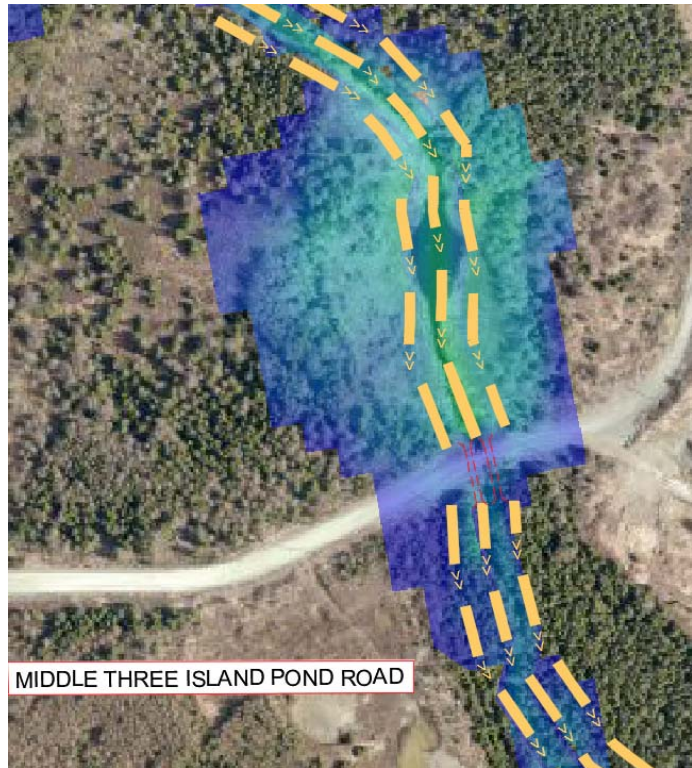
**Figure 13: Flooding Occurring on 100 Yr – 6 Hr CC**

On Middle Three Island Pond Road, there are two CSP culverts with diameters 1400mm and 1000mm CSP culverts that provide drainage between two marshy areas. These culverts are also under capacity during the 100 Yr – 24 Hr CC storm event. This would likely lead to a washout of this gravel road. The floodplain in this area can be seen in the Figure 13.

As mentioned previously, the twin 1000mm on Middle Three Island Pond Road are under capacity which would likely lead to a washout of the gravel road. However, the consequence of failure in this instance is fairly low due to the fact that there is little to no infrastructure in the immediate area. As a result the culvert was modelled using the 25 year design storms, which are typically used when sizing culverts. The 25 Year design storms showed that these culverts sufficiently convey runoff without any overland flow or flooding. As a result it is not pertinent to replace this piece of infrastructure and will not be included in cost estimates included later in this report.

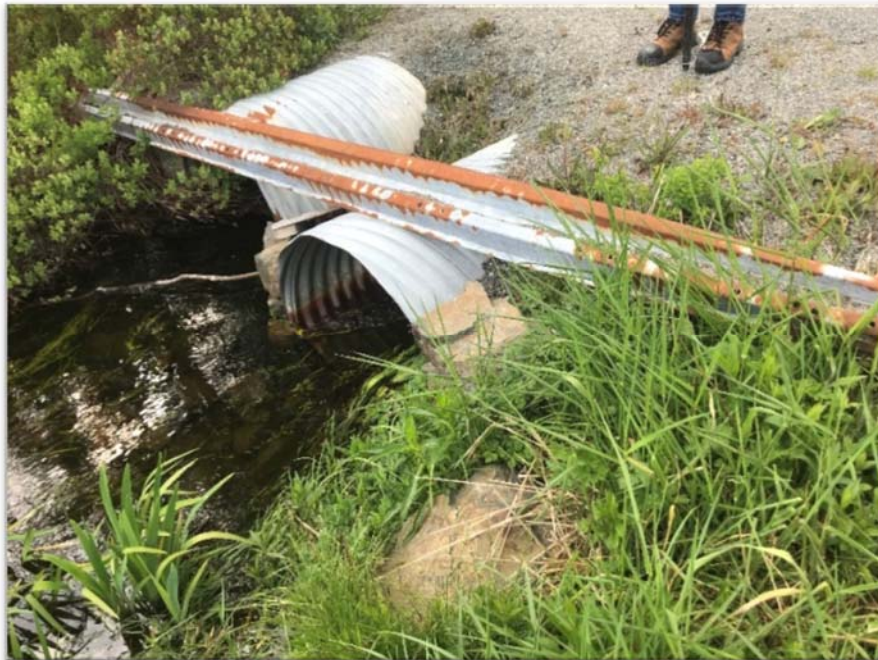
**Figure 15: Twin 900mm CSP Culverts – Woodfine’s Lane**

The catchment area extends to the Robins Pond area, which discharges through twin 900mm CSP culverts on Woodfine’s lane and then through a 1600mm CSP culvert on Bauline Line, shown in the Figure 14.

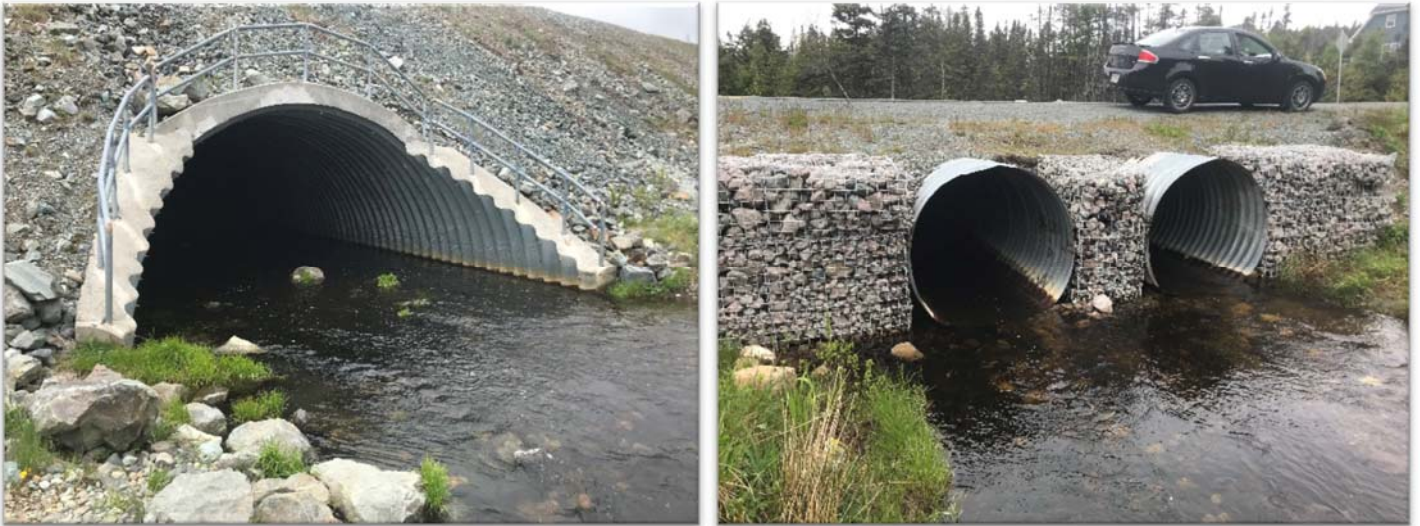
**Figure 16: Culvert Structures on Torbay Bypass Road and Rattling Brook Road**

Further downstream, the runoff is conveyed through twin 1500mm CSP culverts crossing Rattling Brook Road and then through a large culvert structure passing through the Torbay Bypass Road

The most severe storm for this catchment area is the 100 year 2 hour storm. The floodplain for the large Island Pond Brook catchment can be observed in Appendix E One area of concern is in the area of Rattling Brook Road . Near the inlet of the twin 1500 CSP culverts on this street, the stream becomes very flat

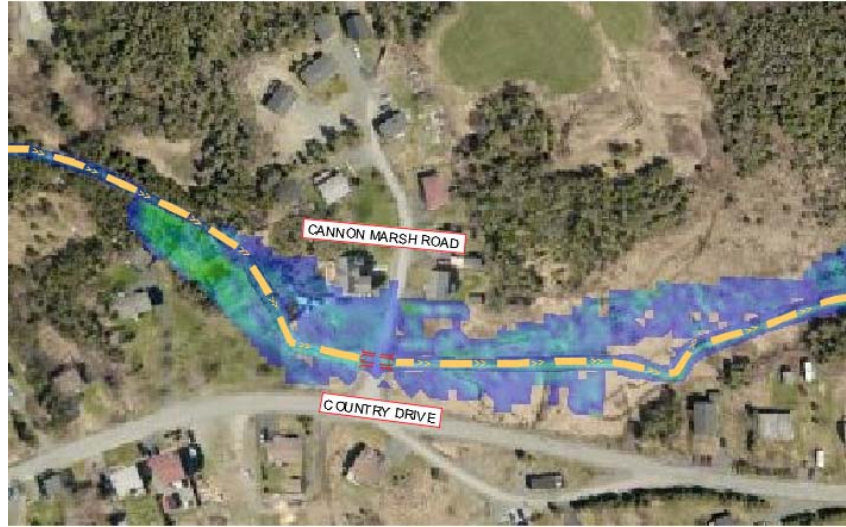
**Figure 22: Resulting Flooding in the Cannon Marsh Road Area**

In the Whiteway Pond catchment area there are several areas of concern upon running 100 year simulations. The worst observable storm that was modelled was the 100 year 24 hour storm. In particular, in the area of cannon marsh road, the natural stream becomes very flat and as a result the twin culverts crossing the road become overwhelmed and the model shows that there is currently flooding. This does not take into account that in the field, it was observed that a concrete barrier is compressing the outlet side of the culverts. This means that in a real world scenario, if the 100 year climate change storm were to occur, it most likely result in worse flooding than observed in the model. This is shown in Figure 22:

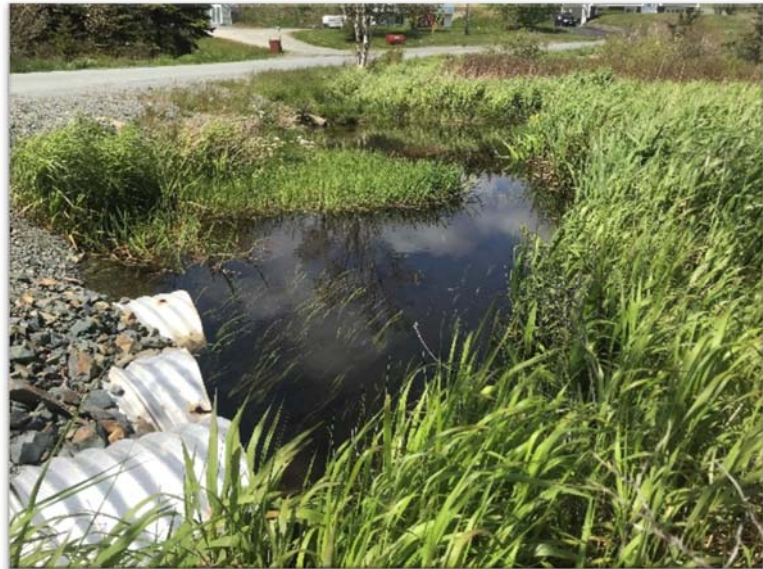
**Figure 25: Triple 600mm CSP Culverts on Crowe's Lane**

The catchment captures runoff from Withrod Pond as well as Watt’s Pond. The runoff from Withrod Pond is conveyed through adjacent marshy areas on either side of Crowe’s Lane through four CSP culverts. Three of them being 600mm in diameter while the other is 900mm in diameter. The marshy area to the north east

of Crowe’s Lane feeds into Watt’s Pond. The implementation of four culverts in this area indicates that there have been drainage issues in the past and these issues still exist. This road has washed out in the past.

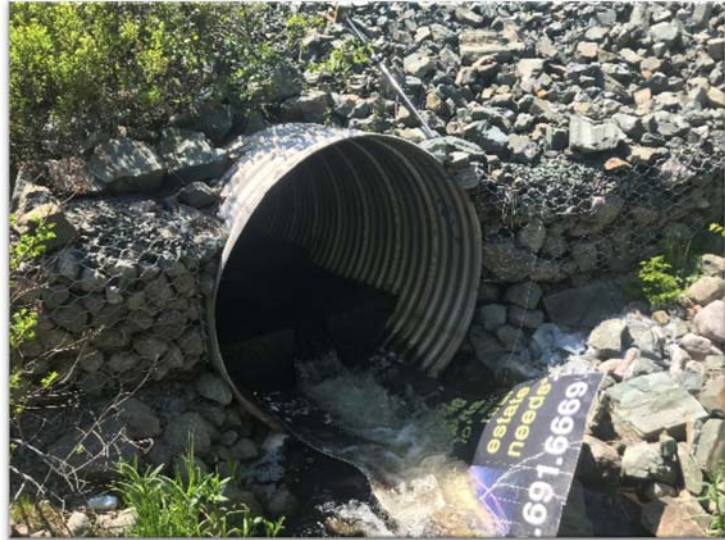
**Figure 28: 2000mm CSP Culvert - Torbay Road**

The runoff from this catchment area meanders through the residential area of Karon Drive and Pine Ridge crescent, crossing streets through local culvert structures. This runoff is conveyed across a 2000mm CSP culvert on Torbay Road, shown in Figure 28. Upstream from this large CSP culvert, a 900mm culvert crosses Rosebud Street which appears to be partially compressed by a large rock, shown in Figure 29.

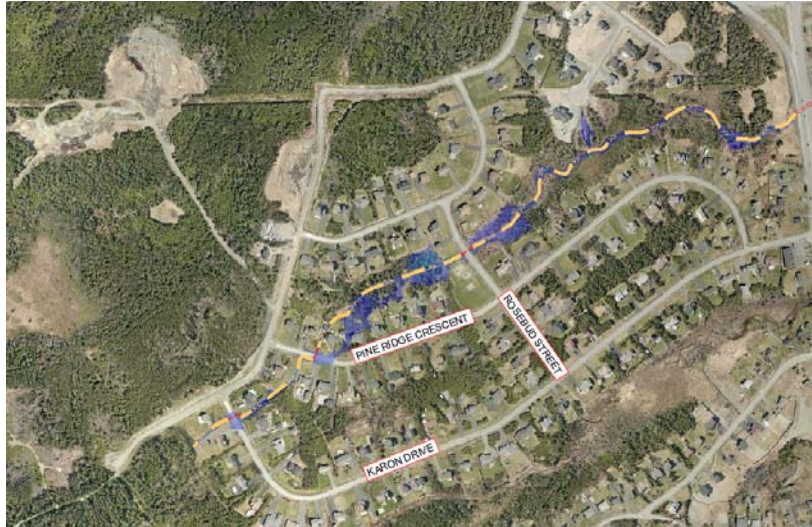
**Figure 5: Kennedy's Brook Catchment Area Floodplain**

Similar to the Big River Catchment, local structures are over capacity during the 100 year 2 hour storm event. This is to be expected given

the severity of the storm. One area of concern is at the location of the 900mm culvert crossing Rosebud Street. The stream has runoff passing over it's banks and the culvert itself is under capacity. As a result overland flow occurs on civic # 29 Cordelia Crescent as well as the playground on Rosebud Street. This can be seen in Figure 30.

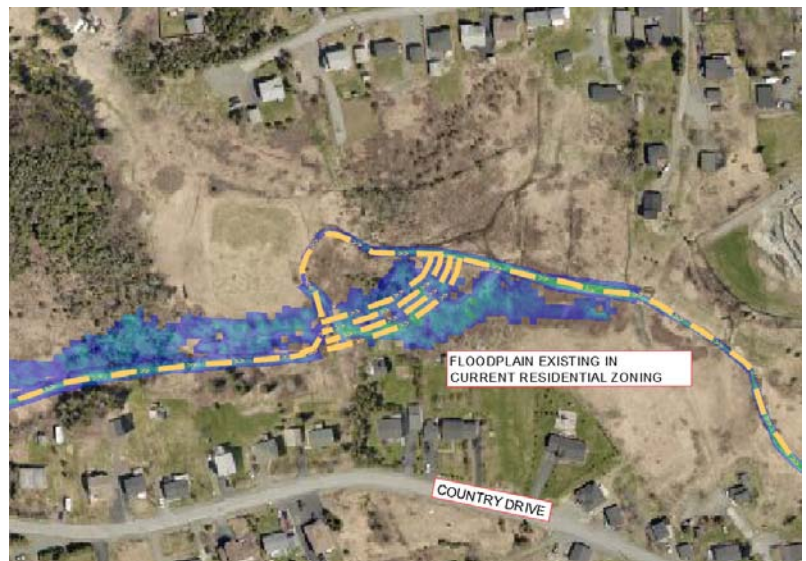
**Figure 31: Floodplain In Potential Development Area**

The Whiteway Pond area has some issues under existing conditions as well. The zoning shows areas of potential development in this area, which will further strain existing storm sewer infrastructure within the catchment. There is an area currently zoned within this catchment as a residential subdivision area. The current floodplain under existing conditions shows significant overland flow resulting from a low capacity stream weaving through the area, shown in Figure 31.

Given the existing elevations and floodplain shown on the previous page, it is recommended that development not take place in this area as it is prone to flood issues.

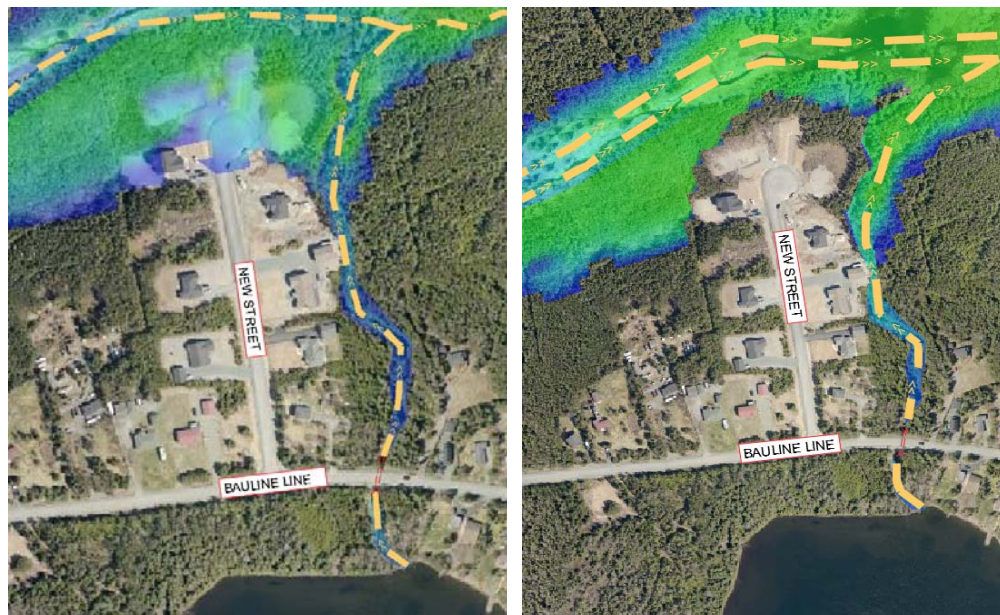
**Figure 32: Forrest River Road Before Upgrades vs Forrest River Road After Upgrades**

As mentioned previously, the natural stream flowing adjacent to the newly developed “New Street” tops its banks and appears to flow onto the new subdivision. An earth berm could be constructed to properly prevent this from happening. The berm will essentially confine the flow to the stream and the surrounding wooded area instead of posing a threat to the surrounding properties.

The berm was modelled in the XPSWMM software and the new floodplain for “New Street” can be seen in the Figure 32. This berm should be at least 3 m in height with side slopes at 2 to 1. A cross-section of this berm can be seen in the concept drawing included in Appendix G.

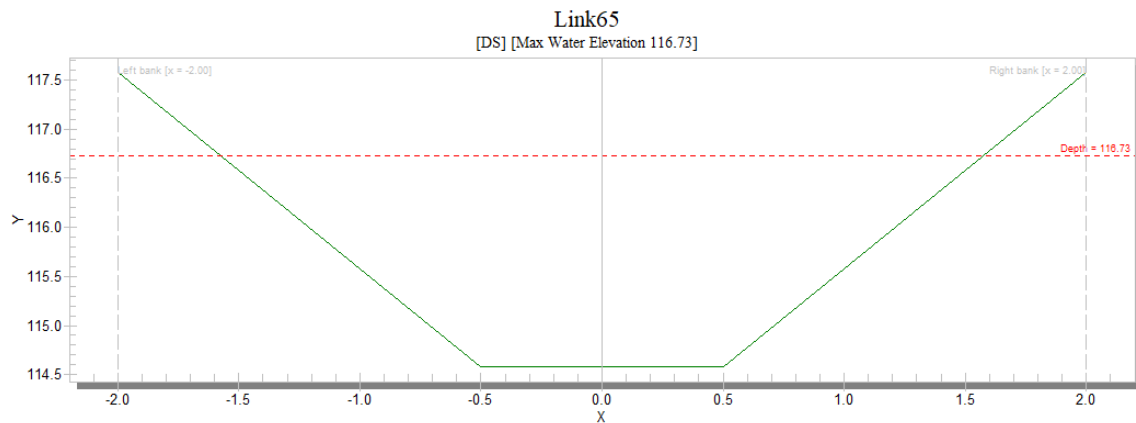
**Figure 33: New Cross-Section**

There is potential for residential development in the Pinch Creek Place area of the Town. Accounting for this increase in runoff, there appears to be an increased amount overland flow. To account for this, the stream should be modified to have the following cross-section when such development is to take place.

This new channel has a bottom width of 1m, a height of 1m and side slopes of 2 to 1. This cross-section allows for better drainage and reduces overland flow and properly routes runoff through the existing infrastructure, preventing flooding.

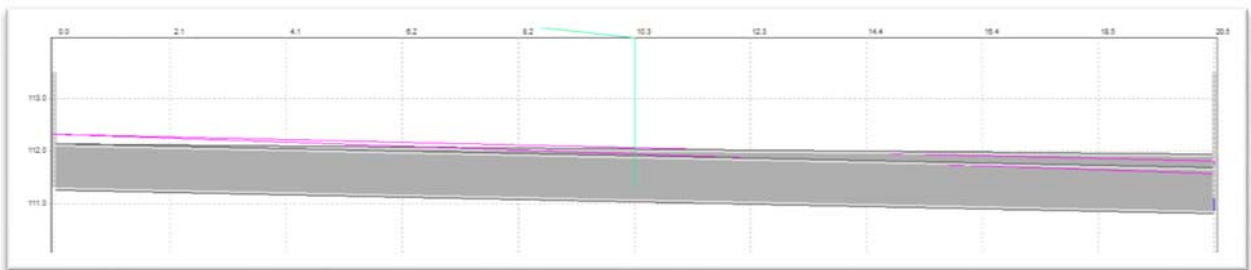
**Figure 34: Twin 800 CSP Culverts - Country Drive**

The twin culverts at Country Drive are under capacity resulting in significant overland flow which would potentially result in that portion of the road being washed out as well as infrastructure damage to the surrounding homes. This can be seen on drawing in Appendix E. The new 800 CSP culverts combined with the berms upstream would provide proper drainage from the pond while preventing infrastructure damage in the area. These culverts can be seen in the figure below, at capacity during the worst storm event.

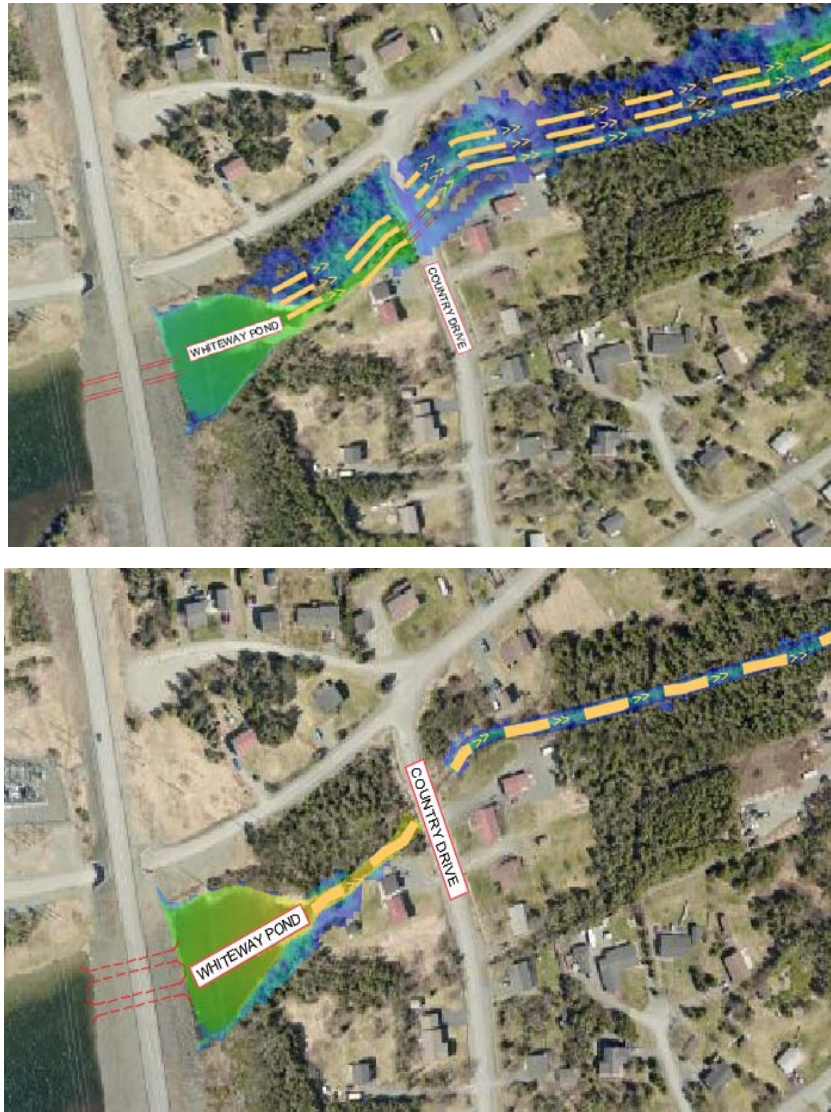
**Figure 35: Country Drive Before Upgrades vs Country Drive After**

Shown below is the before and after comparison of flood limits when these upsized culverts were ran in the models, note that the overland flow on Country Drive and surrounding properties is essentially eliminated from the placement of Earth Berms and the upsized culverts.

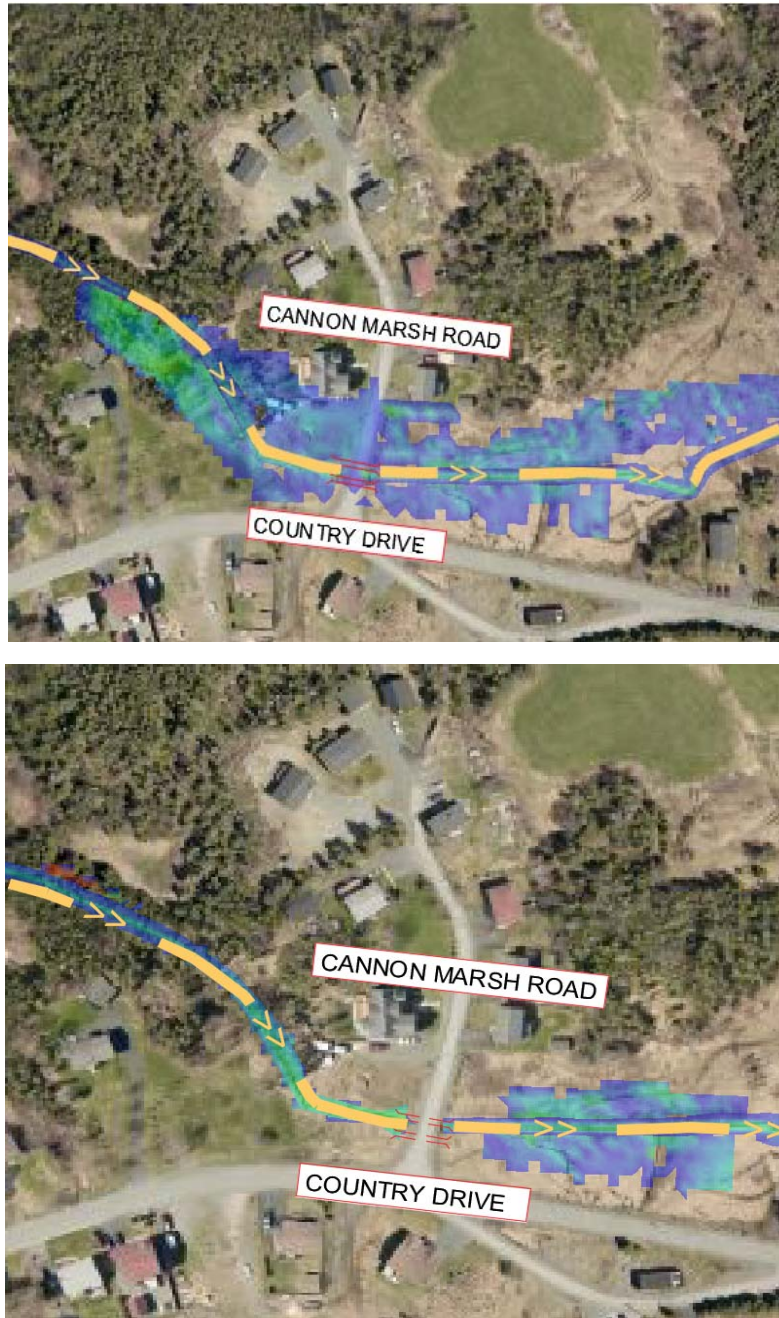
**Figure 36: Cannon Marsh Road Before Upgrades vs Cannon Marsh Road After Upgrades**

Moving downstream from Russworthy Drive, the compressed twin culverts on Cannon Marsh are the next major piece of infrastructure. Both the models, taking into account future development and not taking into account future development, show significant overland flooding and infrastructure damage in this area under the 100 year 24 hour storm event. Given the structural condition of these culverts and the potential of flooding in the area if such a rainfall event should occur, the concrete barrier should be removed and these culverts should be replaced and upsized as soon as possible. An earth berm should be placed on both sides of the upstream side of the

stream to confine the runoff to the existing stream to assist with routing runoff. This earth berm should be constructed with a height of 1.2m with side slopes of 2 to 1.

Given the significance of infrastructure damage if this event were to occur, it is recommended that these twin 600mm CSP culverts be replaced with twin 800 CSP culverts. Shown below is a before and after figure showing the extents of flooding prior to replacing these damaged culverts and no modifications to the existing stream.

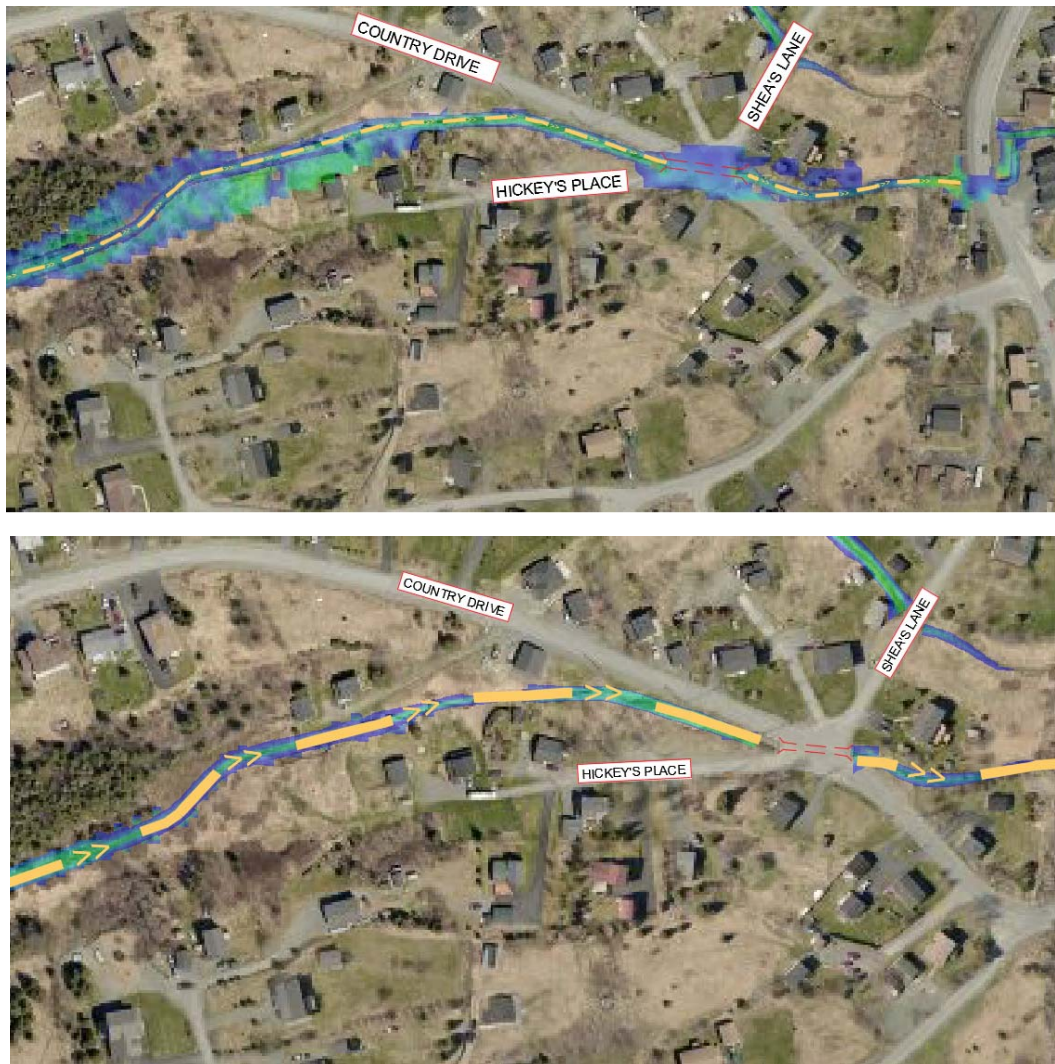
**Figure 37: Hickey's Lane Intersection Before Upgrades vs Hickey's Lane Intersection After Upgrades**

In the area of Hickey's Lane, the natural stream passing adjacent to Hickey's Lane appears to be at capacity and overland flow can be observed on the properties of nearby homes. The low capacity of this natural stream also allows poor conveyance through the existing 900mm CSP culvert, resulting in a potential washout in this intersection. By constructing a berm along the stream it confines the flow to the stream itself preventing overland flow and allowing for proper drainage through the 900mm CSP culvert, preventing property and infrastructure damage and prevents having to replace the existing culvert. This berm should be constructed at a minimum height of 1.2m with side slopes of 2 to 1.

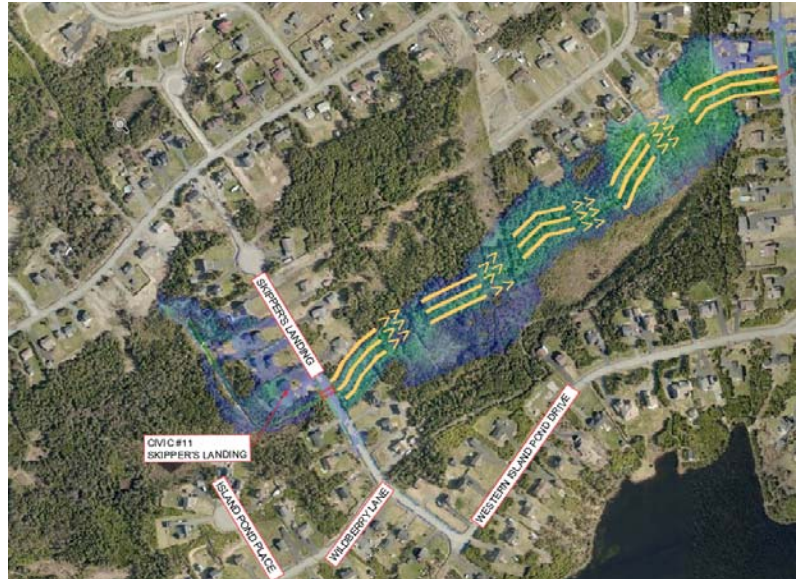
Figure 38: Skipper's Landing Before Upgrade

This catchment requires significant remedial action to mitigate potential flooding issues that have been well documented in this area. In a previous project PEC proposed to mitigate these flooding issues by altering the drainage channel at the rear of Skipper’s Landing to allow for greater capacity as well as lowering the ditch below the basement elevations of the homes adjacent to the cutoff ditch. The alterations to the cutoff ditch include deepening and widening as observed in Appendix G. This will allow for additional capacity in the ditch and help prevent saturation of the adjacent soil. The proposed upgrades suggested by PEC also provides details on updating the presence of reverse graded roadside ditches to ensure proper drainage out of the area. This can be seen in greater detail in Appendix G. This will help prevent ditches from filling or remaining partially full after a rain event and prevent any backflow through weeping tiles or raising the water table in the area. These upgraded conditions can be observed in Appendix H To

further prevent overland flow from the cutoff ditch at the rear of the properties, an earth berm could be constructed along the perimeter of the ditch to prevent flow from passing onto the adjacent properties in the event that the water levels should surpass the banks of the stream. The

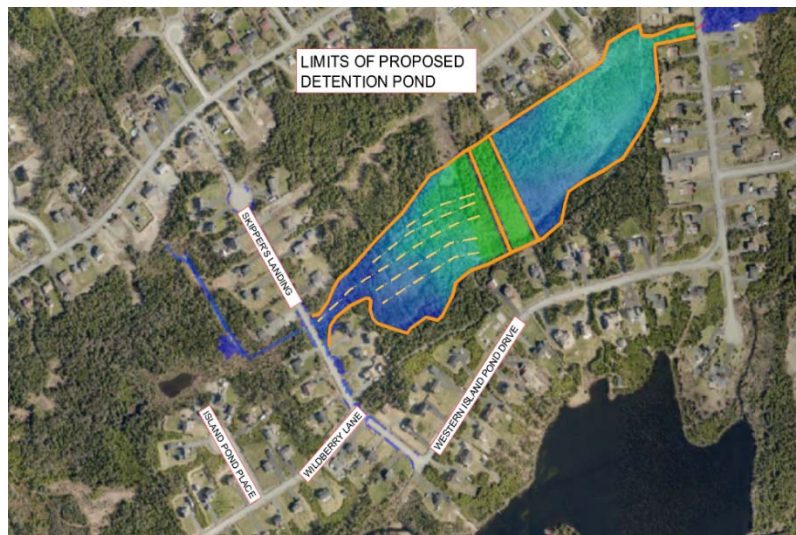
Figure 39: Skipper's Landing After Upgrade

before and after floodplains for the 100 year 2 hour storm event can be seen in the Figures 38 and 39. Note the dramatic decrease in overland flow from both the cutoff ditch as well as the roadside ditches. The large detention pond structure helps reduce flow in the downstream marshy area. As well as preventing overland flow at the rear of homes on the eastern side of Skipper's Landing.

Building upon these previous recommendations, to help reduce flows downstream and to reduce ponding in the wooded/marshy area to the north east of Skippers Landing, a detention pond could be constructed to help detain some of the runoff that would occur during a heavy rainfall event. It is important to construct this detention pond structure to ensure that peak water levels are beneath the finished floor elevations of any houses in the area in the event that the water within the detention pond structure should reach an elevation high enough to saturate the surrounding soil which could possibly lead to basement flooding. To ensure a proper concept design, PEC conducted a detailed topographic survey to note the basement elevations of houses surrounding the proposed area. The detention pond must be able to accommodate the existing flood conditions associated with the most severe 100 year climate change storm as well as accounting for future development that may feed into the area. To ensure water levels are kept below basement elevations of surrounding homes, the detention pond has been divided into three main detention areas.

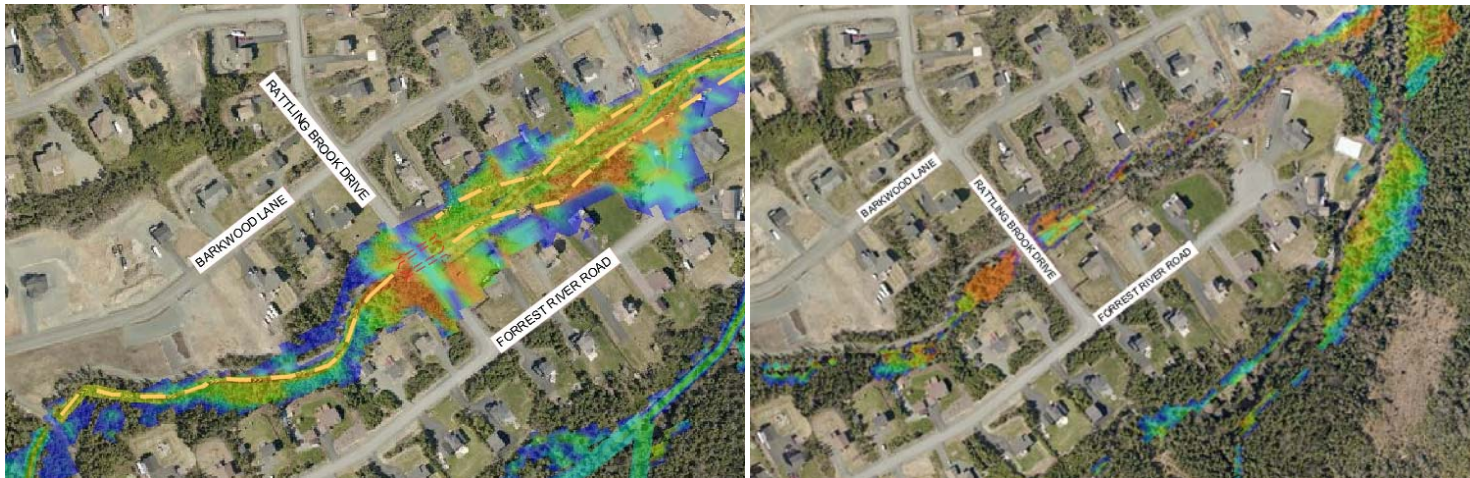
**Figure 40: 100 Year 2 Hour Floodplain Before Upgrades vs After Upgrades**

As noted, there is considerable overland flow in the Rattling Brook Road/Forrest River Road area. This is due to the low capacity of the stream that conveys runoff from the area and the twin 1500mm CSP culverts are under capacity. This results in immediate flooding on Rattling Brook Road and could potentially lead to a washout. As a result it is recommended that berms should be

place on either side of the inlet and outlet portions of the streams to confine the runoff to the stream itself and to prevent runoff from spilling the banks of the stream. To ensure proper runoff it is also recommended that the twin 1500 mm CSP culverts be upgraded to twin 2000mm culverts. The consequence of failure in this scenario is severe as a road washout is likely as well as significant property damage. Further downstream, earth berms should be constructed on either side of the stream to prevent overland flow passing onto the end of Forrest River Road, causing further property and infrastructure damage. Shown on figure 40 is a before and after figure of the floodplain in the immediate area, showing that the remedial actions suggested will help prevent flooding issues should the 100 year storm event occur.

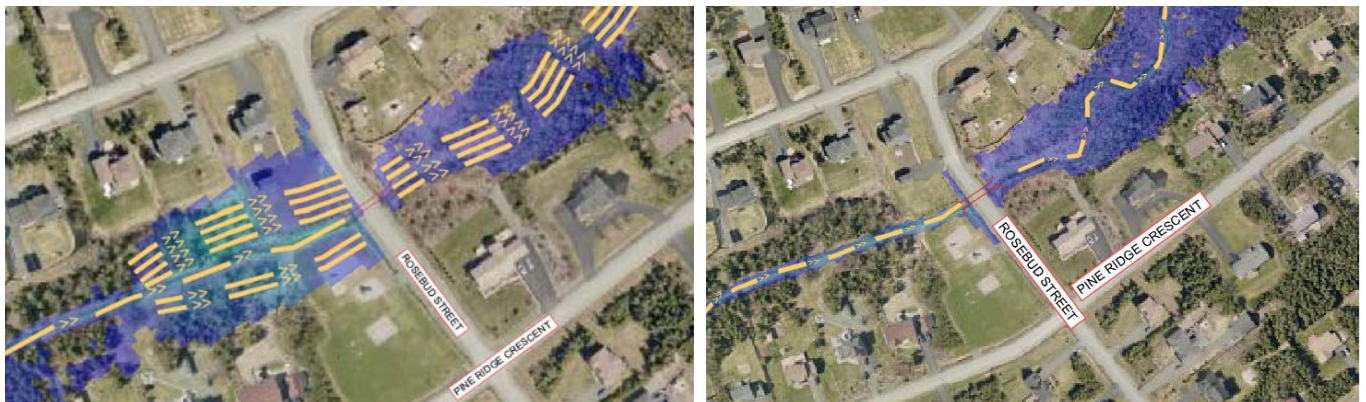
Figure 44: Rosebud Street Before Upgrades vs Rosebud Street After Upgrades

Shown below, the stream conveying runoff in the Rosebud Street area spills its banks upstream of Rosebud Street, resulting in overland flow on a nearby property as well as a nearby playground

Placing an earth berm with height of 1.5m and side slopes of 2 to 1 will help confine the runoff to the stream and allow for better drainage, preventing the overland flows mentioned. As mentioned earlier in the report the 900mm CSP culvert crossing Rosebud street should be replaced and upsized to a 1200mm CSP culvert due to the damage evident through field inspection and to accommodate for anticipated increases in runoff.

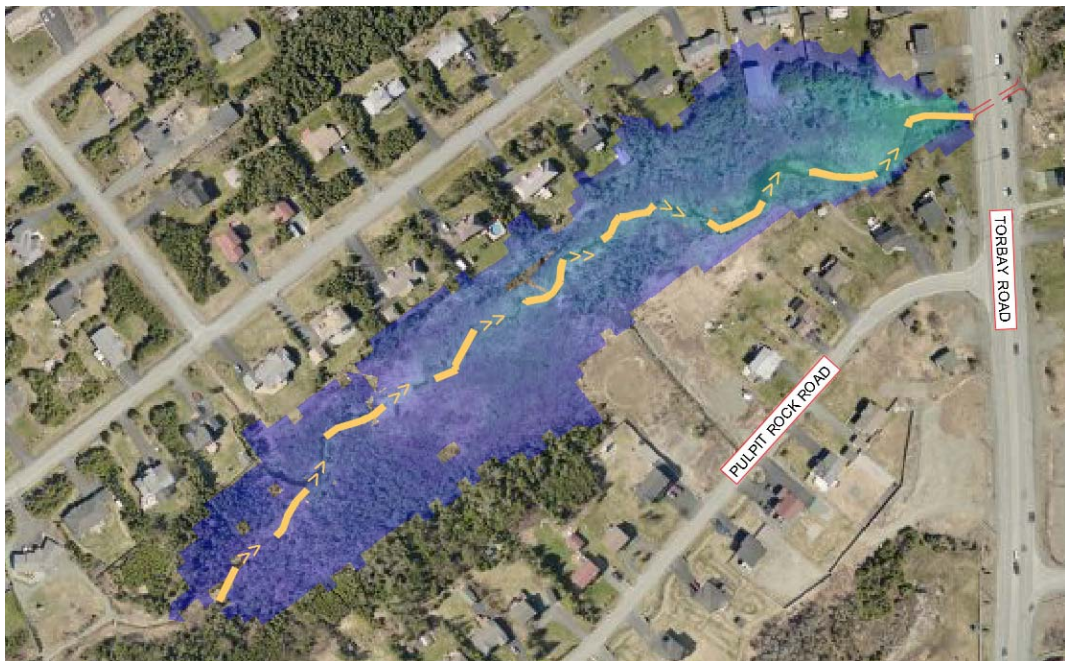
**Figure 45: Floodplain Impacted by Potential Commercial Development**

The future industrial lots will likely drain through the existing 2000mm CSP culvert crossing Torbay Road. Analyzing this future scenario through the XPSWMM model shows some overland flow occurring due to the stream surpassing its banks.

The floodplain shows some areas where the floodplain is encroaching on to nearby properties. In the event that future commercial development occurs upstream from this area, an earth berm can be constructed along the property lines of the homes of concern. Its important to analyze the potential impact that this commercial development would have on infrastructure downstream in the Town of Middle Cove – Outer Cove as it could create issues downstream. If a commercial area is to be developed, a local detention structure could be considered as well to detain runoff specific to the new area to help reduce impacts downstream.

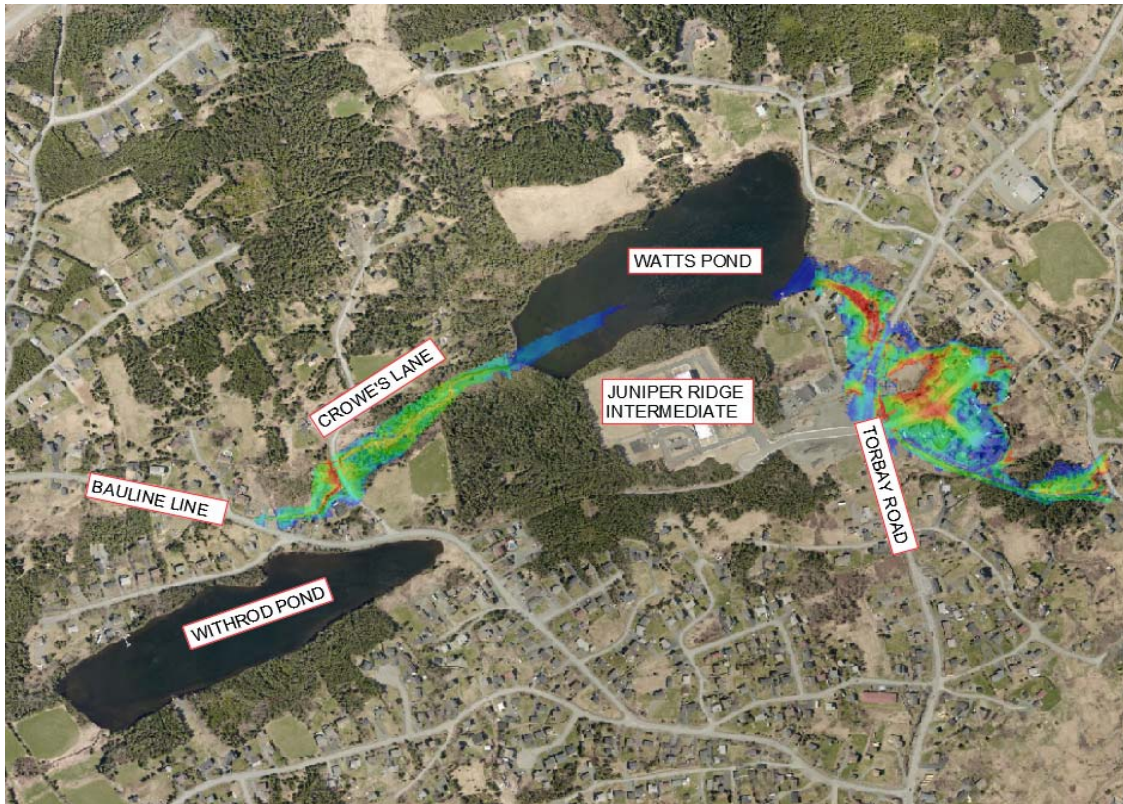
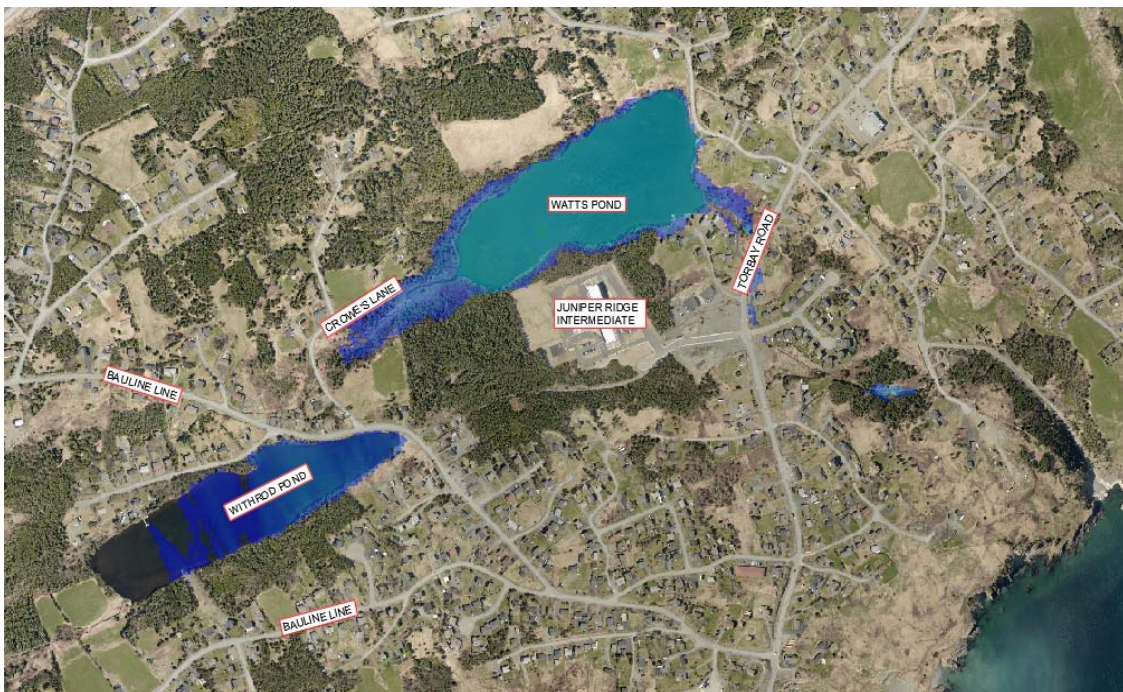
Figure 47: Watt's Pond Catchment Before Upgrades

Figure 48: Watt's Pond Catchment After Upgrades

A possible solution to the issue surrounding flooding on Anstey's Cove Lane would be to lower the water levels present in Withrod Pond and Watts Pond by 1 foot. The ponds will eventually adjust to the new water level. The decrease in water levels would allow for a large amount of storage and would help reduce flooding conditions in the area and prevent the need for significant infrastructure upgrade and replacement. Modelling the scenario where a foot of storage across both ponds is obtained shows that the flooding issues down stream on Anstey's Cove Lane are resolved. Downstream of Withrod Pond there is currently a small stream passing between Civic # 132 and 131 Bauline Line that currently conveys runoff from Withrod Pond. This stream is currently very small and should be upgraded to have a cross-section with 1m depth, 1 to 1 side slopes and a bottom width of 1m. This will allow runoff to be properly conveyed away from the area while preventing flooding on Civic # 132 and Civic# 131 Bauline Line. The ditch running along Bauline Line meanders through a flat marshy area at the rear of Civic# 132 and 131 on Bauline Line. There is little elevation change between this marsh area and the existing top water elevation of Watt's Pond meaning if a new ditch is to be constructed in this area, its slope will be very small. To properly convey runoff away from the area a widened cross-section with a minimum depth of 1m could be constructed. The older stream could be filled in and abandoned. With regards to the four culverts crossing Crowe's Lane, given the increased storage of Withrod Pond and the new ditch cross-section, twin 1400mm CSP culverts can be placed to provide drainage between the two adjacent marshy areas surrounding Crowe's Lane. Downstream of the upgraded culverts, the existing stream should be modified to have a total top width of approximately 40m, a bottom width of 20m and a minimum depth of 1m. Runoff will then enter Watt's Pond where the water elevation has been dropped by a foot, providing a foot of storage across the entire pond. This storage, in conjunction with the storage and upgrades upstream helps prevent overland flooding and infrastructure damage on Anstey's Cove Lane and Davalan Place. Shown on the following page is a before and after figure comparing the extents of the 100 year 24 hour floodplain.

possible, lowering the pond elevations of both Withrod and Watts Pond would be the best potential solution for this catchment area.
